10.10.Fire and Rescue NSW Inspection Report - 229 Miller Street, North Sydney

**Re: INSPECTION REPORT
VANTAGE
229 MILLER STREET
NORTH SYDNEY ("the premises")**

Pursuant to Section 9.32(1) of the *Environmental Planning and Assessment Act 1979* (EP&A Act), Authorised Fire Officers from the Fire Safety Compliance Unit of FRNSW inspected 'the premises' on 3 June 2025.

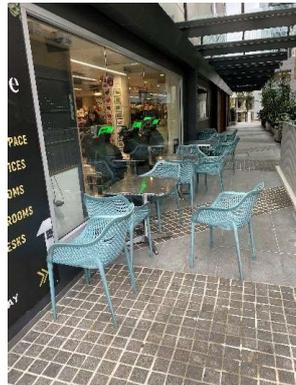
Image 1

Additional information was supplied by the complainant on 24 June, showing chairs and tables located in the path of travel from “the premises” to Miller Street (See Image 1).

FRNSW were advised by the manager of the IGA store that the area shown in *Image 1*, forms part of their lease agreement. FRNSW are of the opinion that the pathway is part of 229 Miller Street allotment and believe it to be part of the exit strategy to Miller Street.

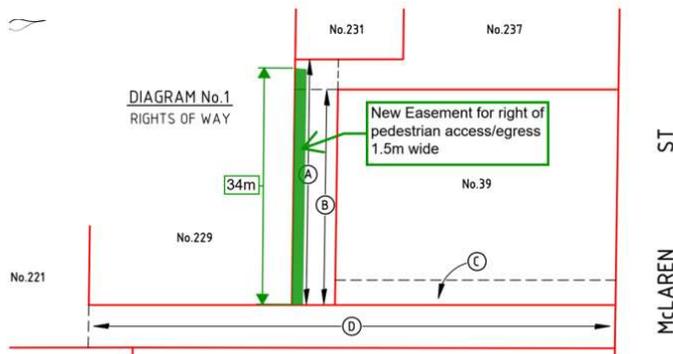
Figure 8-41: Right of Egress Relative to the Site

To ensure that the egress pathway is always kept clear, the Performance Solution will require the Right of Egress be provided which provides occupants with unrestricted access onto Miller Street of which is to be maintained for the life of the building. The Right of Egress must have a width of 1.5m and a length of 34m and must be in favour of the 229 Miller Street and be registered with the Department of Land and Property Information.

To ensure the discharge of the exits remains available throughout the life of the building and the use of the adjacent allotment's easement is not altered, the easement shall be identified as an Essential Fire Safety Measure and be included on the Fire Safety Schedule
