**SUBJECT:** Request for Removal of Tree Located in Margaret Street Road Reserve

**Inspection of Damaged Stone Boundary Wall at 2-6 Margaret Street North Sydney**

### **INFRASTRUCTURE DAMAGE ARBORICULTURAL ASSESSMENT REPORT**

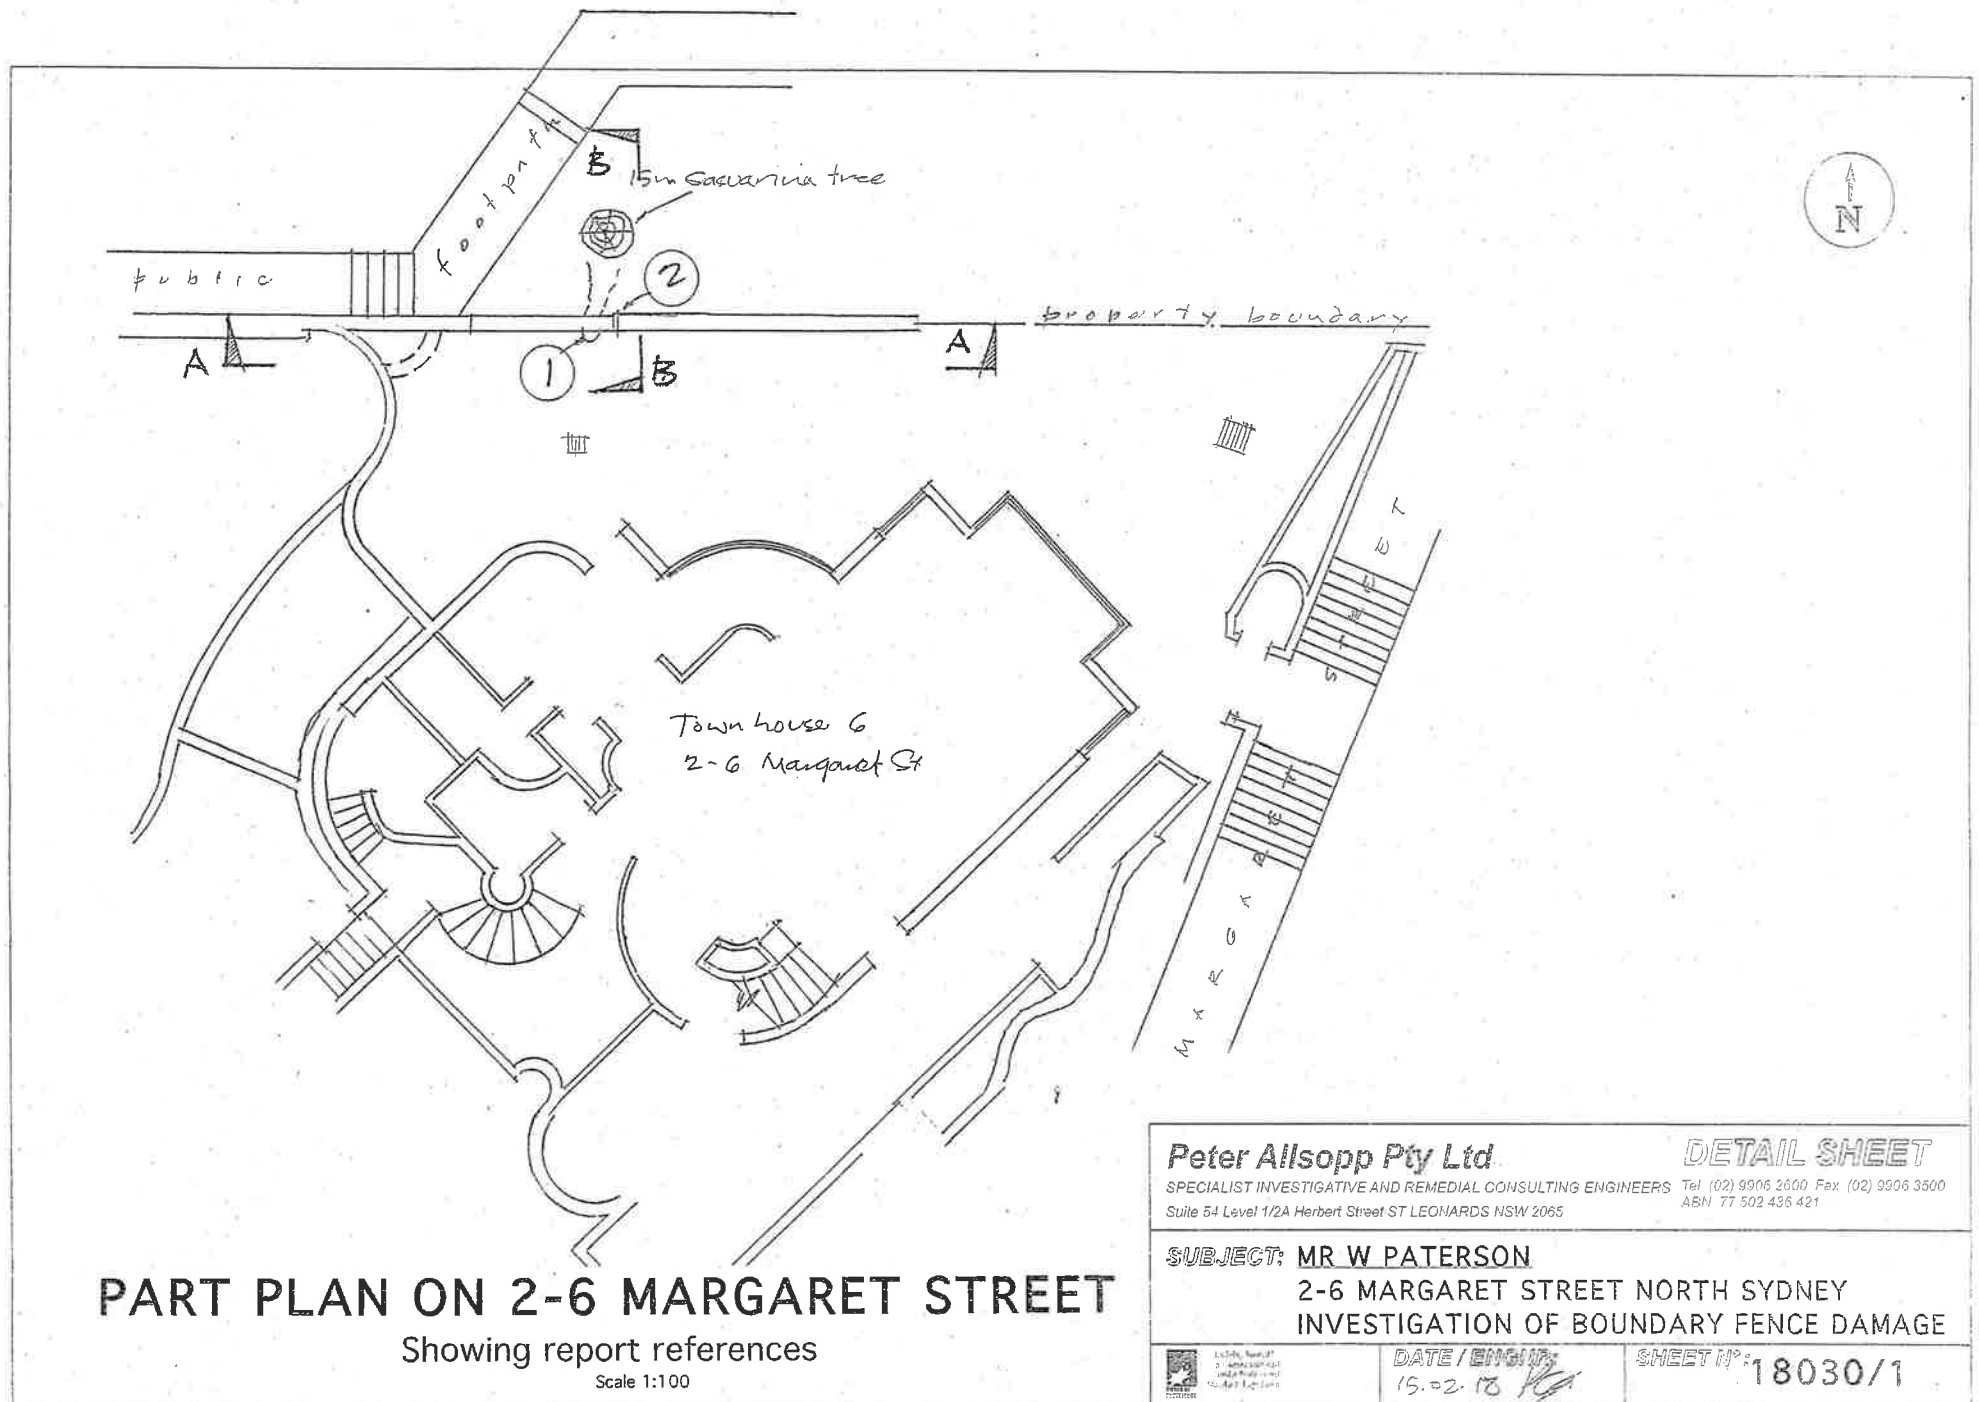
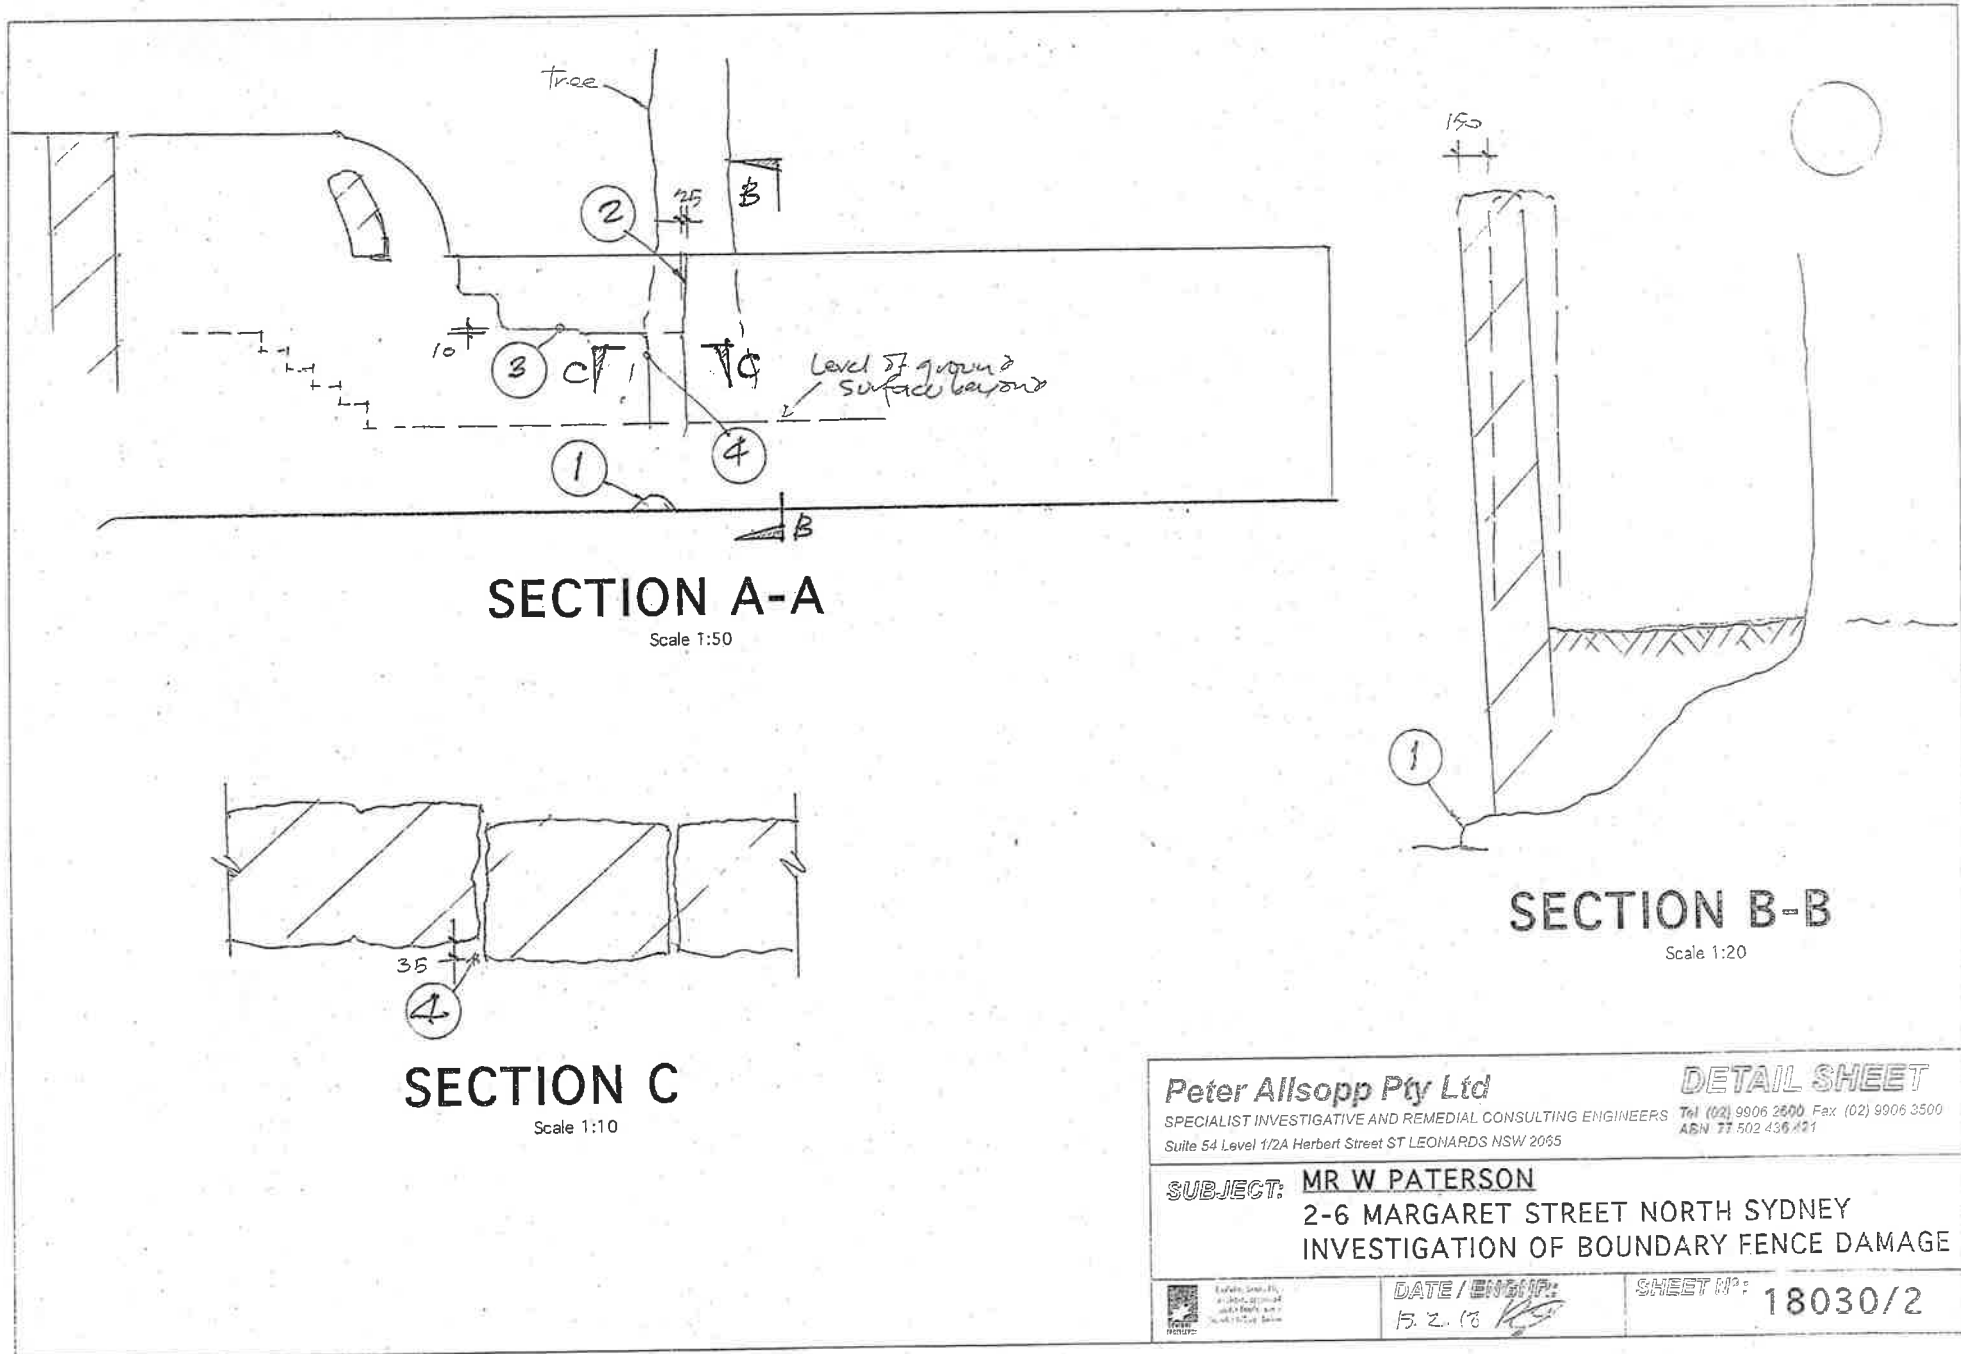
Referring to my accompanying A3 Drawing No.18030/1, which has been based on my site measurements, the wall is 2.5 metres high with a free-standing length of 9.25 metres. It stands on the common boundary between the 2-6 Margaret Street town house complex and a public footpath right-of-way (Doris Lane) linking Doris Street to the pedestrian-only section of Margaret Street.

During my site visit I found that the stonework at a point adjacent to the tree had tilted by 150mm from the vertical (3.5° from the vertical), that (at least) one of the roots of the tree had

penetrated through the base of the fence (at the position marked "1" on Section A on Drawing No.18030/2), that a vertical crack (marked "2") had developed which had a width at its top of 25mm, and that the section of stonework to the west of the vertical crack had lifted, so that there was a 10mm horizontal crack (marked "3") extending 2.25 metres back to the point where the top of the fence was effectively given lateral support from the wall of the adjacent townhouse no.6. There is an out-of-plane dislocation of 35mm in the stonework at the vertical split at location "4" (see Section C).

- [a] Shoring the wall against collapse.
- [b] Initially, to excavate around the tree in the garden bed to ascertain whether there were any other roots likely to affect the wall.
- [c] Removing the stonework from the base of the wall over the root at "1" and at the position of any other roots that may be growing near or under the wall, and temporarily propping to support the upper stone.
- [d] Constructing a reinforced concrete beam over the root(s) to give a suitable gap to accommodate future growth, dry-packing the beam to the stonework and seating the supports of the beam on the bedrock.

- [e] For good measure, rock bolts should be set into the bedrock at the supports to provide further restraint against uplift.

This would adversely change the appearance of the wall. Realistically, the reinforced concrete beam would need to be 300mm deep, with a 100mm gap above the root(s), resulting in about 500mm-600mm height of the existing stonework needing to be removed from the base of the wall over an estimated length of up to 6.0 metres. Overall I expect that about 30% to 50% of the wall may need to be relaid.

The tree is healthy and still growing. Clearly the bottom of the wall has been lifted and the gap at the base threatens to allow further problems in the future from other roots. In my opinion, the basic problem is that such a large tree should not have been planted adjacent to a masonry fence. I believe that the most practical solution to the danger posed by the tree to the stone wall would be for Council to agree that the tree can be removed, to be replaced possibly with a smaller tree offering no threat to the wall.

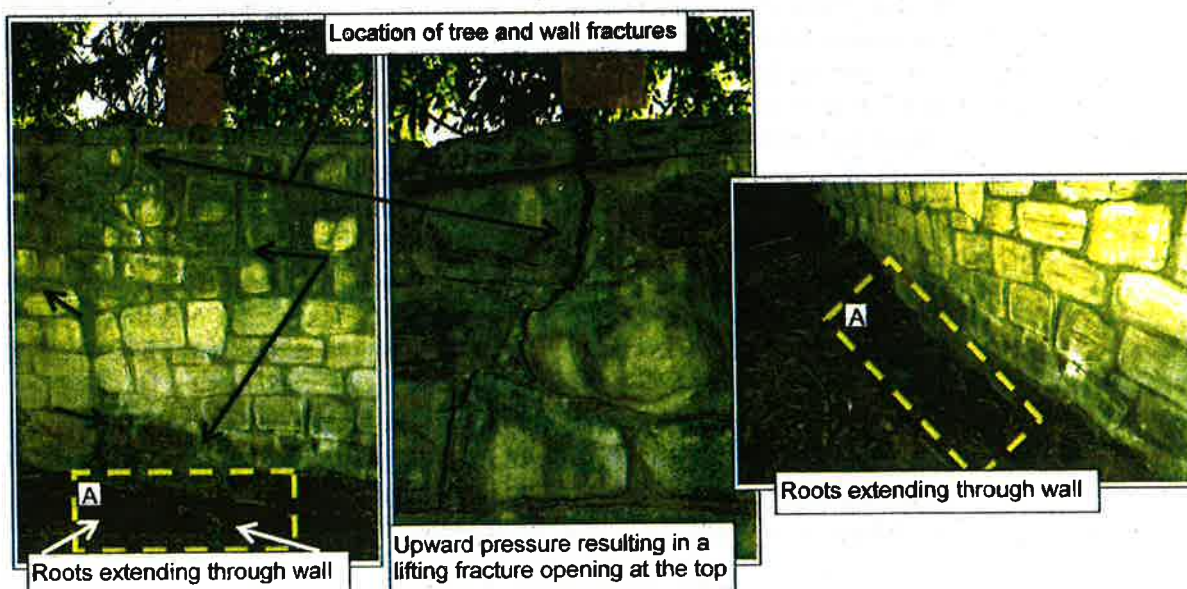
3. Based on visual assessment the sandstone wall contains two (2) significant vertical cracks open at the top of the wall with associated horizontal fracturing from wall movement. The wall itself bows slightly, is approximately 2.1m tall being constructed of random single block sandstones near 250mm in width and appears to have the potential to collapse. Probing the soil adjacent the wall indicated that a solid base exists. It is unclear if a base foundation was constructed or the wall sits on natural rock.
4. Located within an open trench and directly adjacent the tree large tree roots have penetrated through the mortar courses between foundation and base sandstone. The upward pressure of the root system appears to be a main contributor to the failure of the wall as the foundations and base sandstone appear to be stable.

Figure 1, showing tree location & wall damage

5. In determining that the tree is the most likely cause of wall damage the location of the tree at near 1m from the wall suggests that the tree was planted too close to infrastructure. In reference to Costello & Jones: It is very important to know the actual tree diameter at ground level (at tree maturity) to determine the size of the planting space needed for the species. This reduces the potential for trees being planted in spaces that are too small to accommodate their growth (Costello & Jones 2003). Harris (2004) also states that the closer the hardscape to the trunk, the more likely the presence of conflict, with Cutler (1995) indicating pavements (sidewalks) and boundary walls with little or no foundation can be lifted by large shallow roots. In this case the upward pressure of the exposed root system within the site indicate that encroaching roots have contributed to the failure of the wall.

9. Based on the current situation the following recommendations are provided
  1. Obtain council consent to remove the tree as the tree will always be problematic due to its location

2. Consult with engineers with arboricultural advice to bridge over the root system such that the root system is retained and tree anchorage is not disrupted. Addressing ongoing root interference for stormwater management should also be considered as the root system will naturally occupy the small court yard.

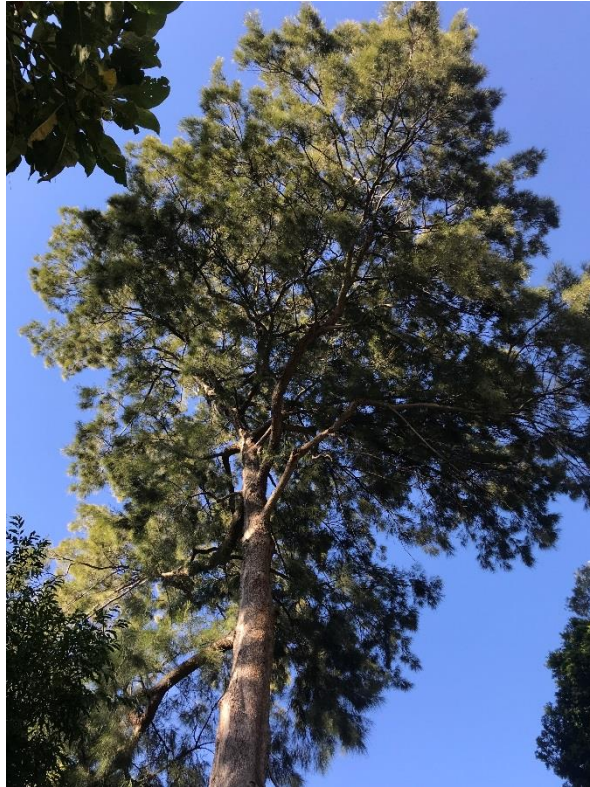
Photo1 - viewed from Margret Street Road Reserve

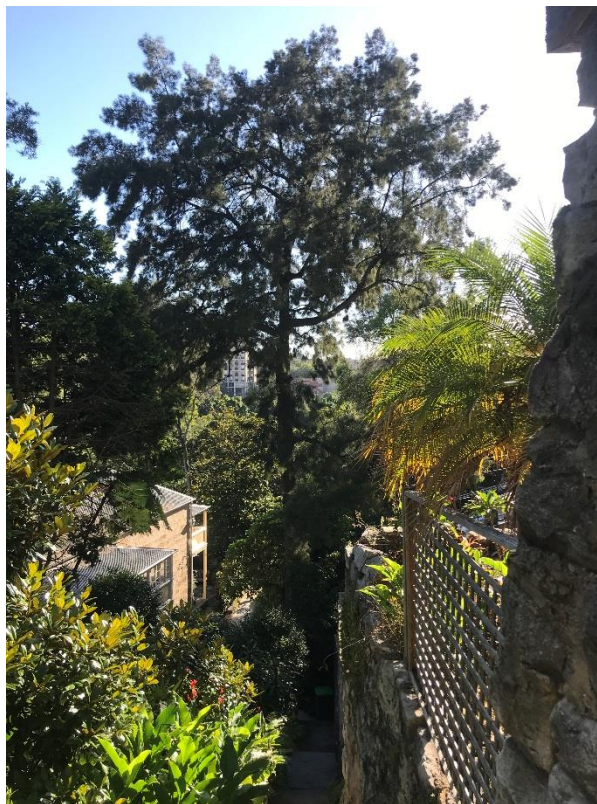
Photo 2 – viewed from Doris Lane.
