NORTH SYDNEY COUNCIL

# ASSET MANAGEMENT PLAN

OTHER INFRASTRUCTURE ASSET CLASS

2025/35

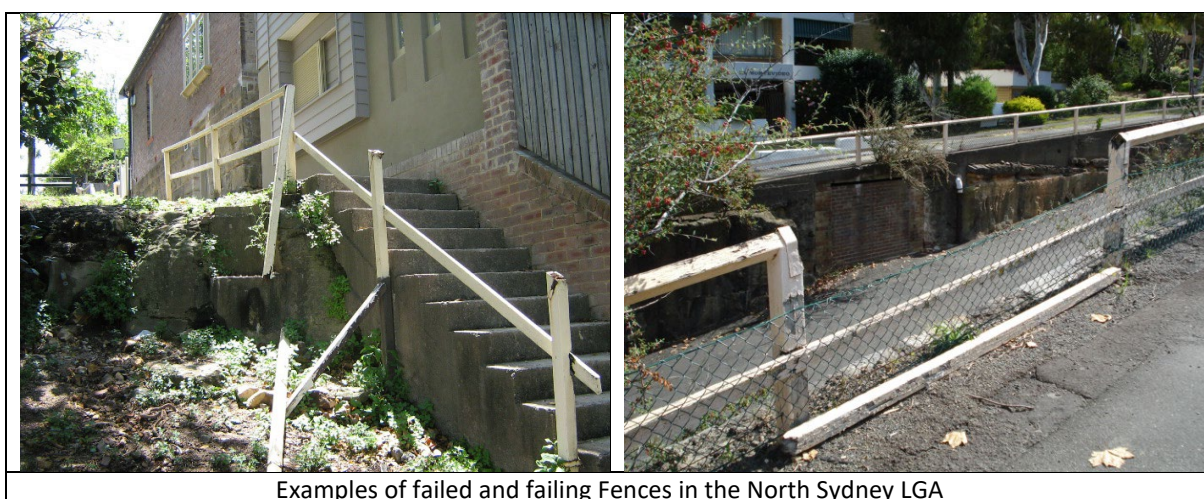
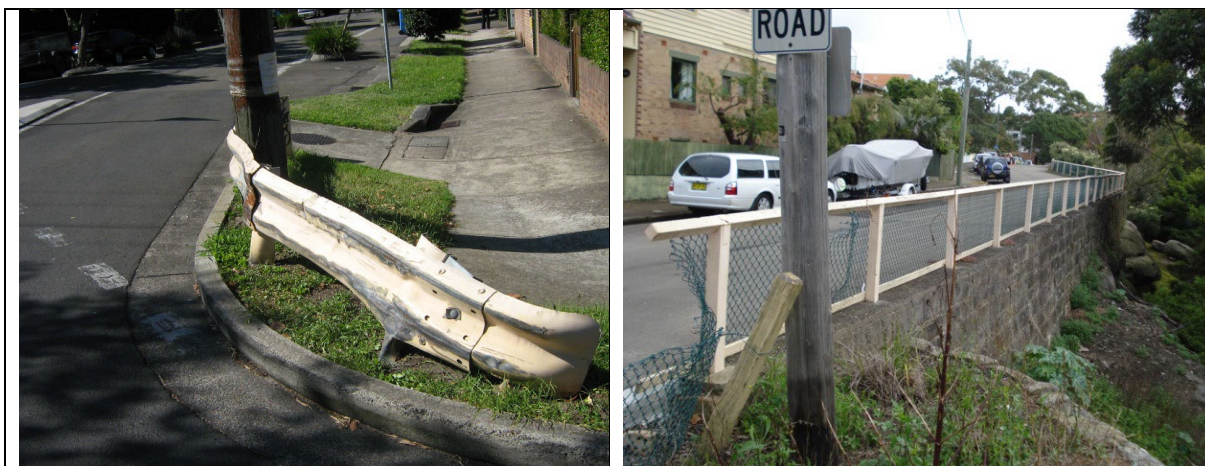
## 6.1 Examples of Fence risks in the North Sydney LGA.

Examples of failed and failing Fences in the North Sydney LGA

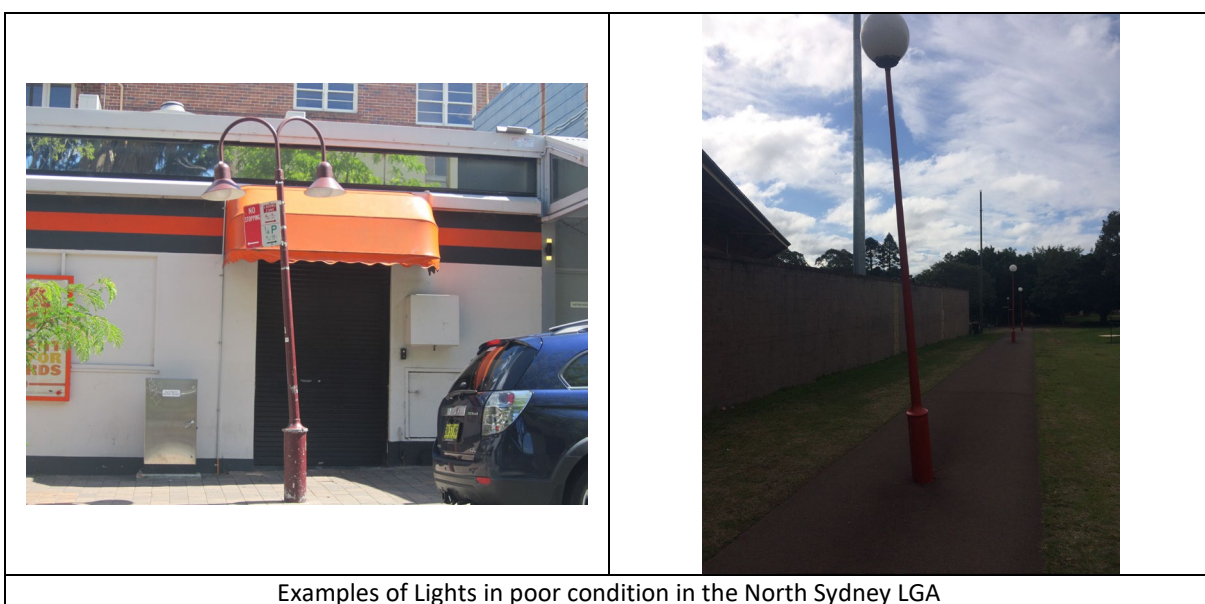
## 6.2 Examples of Lighting risks in the North Sydney LGA.

Examples of Lights in poor condition in the North Sydney LGA

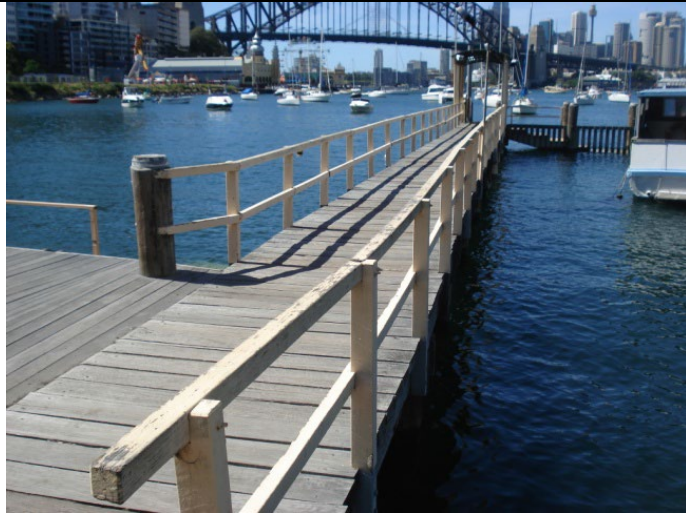
Marine Structures - Lavender Bay Jetty - before

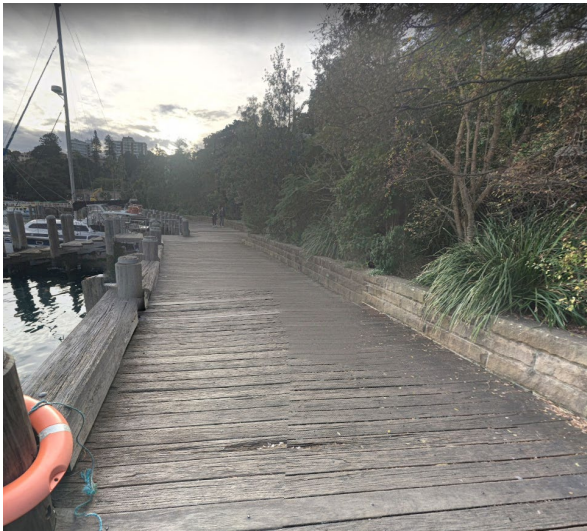
Marine Structures - Lavender Bay Boardwalk - before

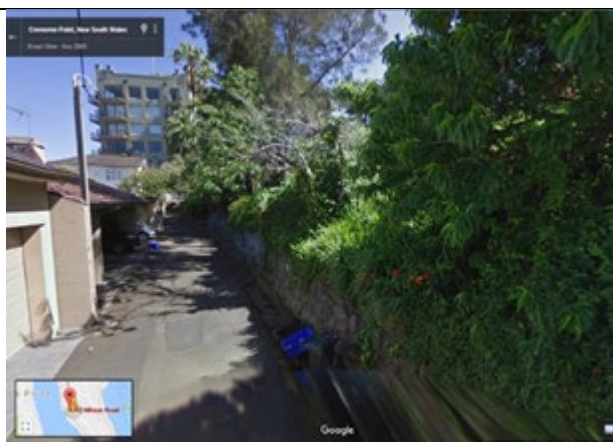
Retaining Wall - Milson Road, Cremorne - Before

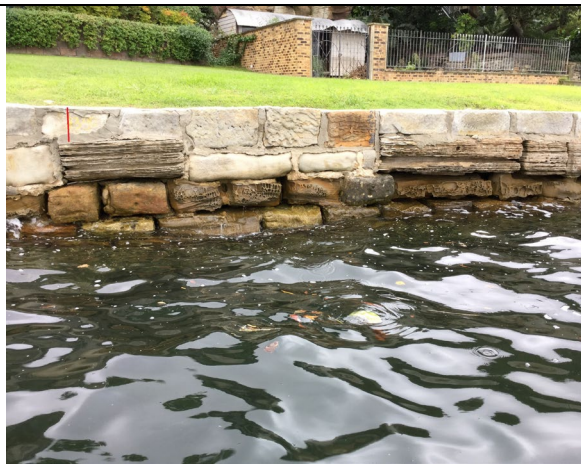
Seawall Grout Injection rehabilitation at Sawmillers Reserve — before

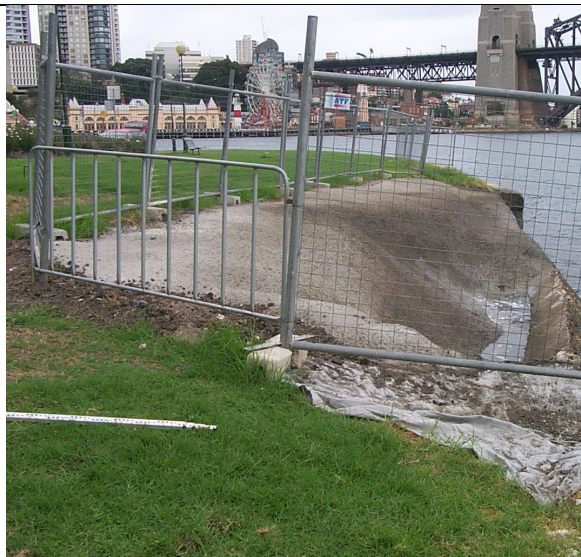
of sudden failures some sections of seawalls have previously collapsed into the harbour before rehabilitation could be conducted. The seawall at McMahons Point fully collapsed which required full reconstruction in 2006.

Seawall reconstruction at McMahon's Point — before
