NORTH SYDNEY COUNCIL

ASSET MANAGEMENT PLAN

STORMWATER DRAINAGE ASSET CLASS

2025/35

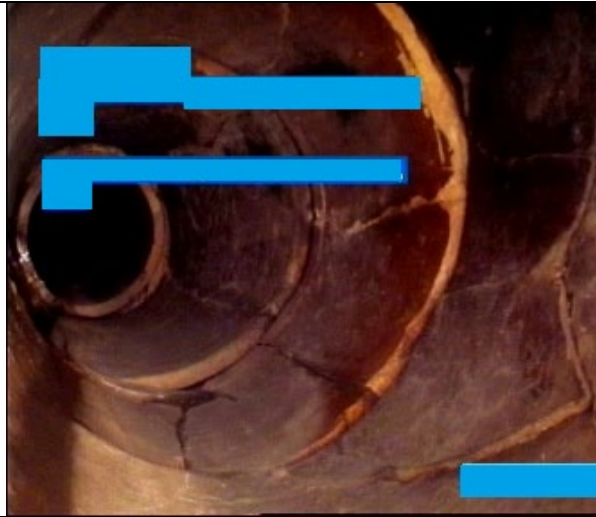
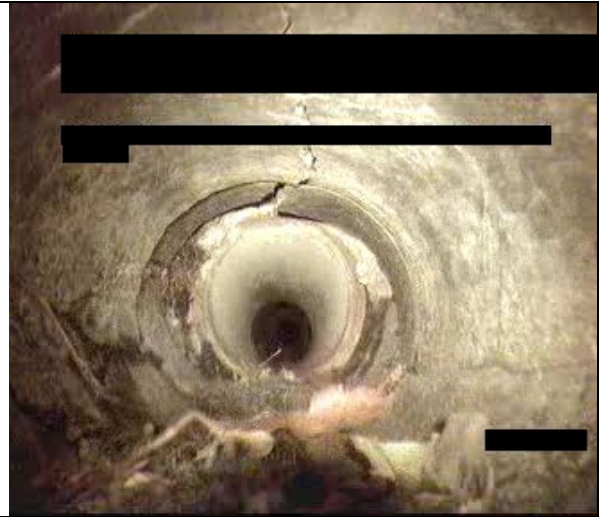
Stormwater Pipes in very poor condition – collapsed and blocked

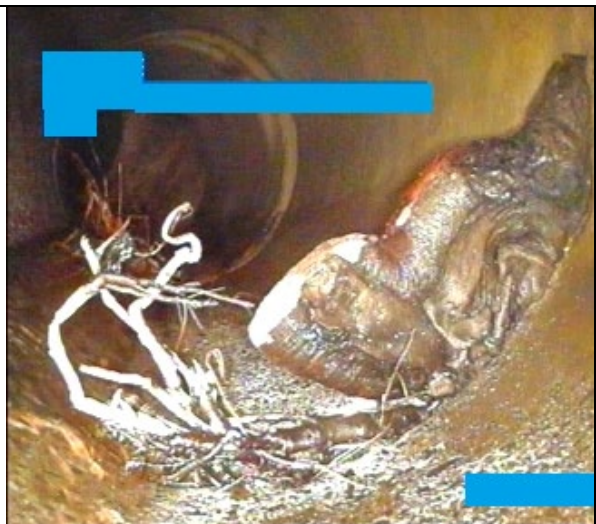
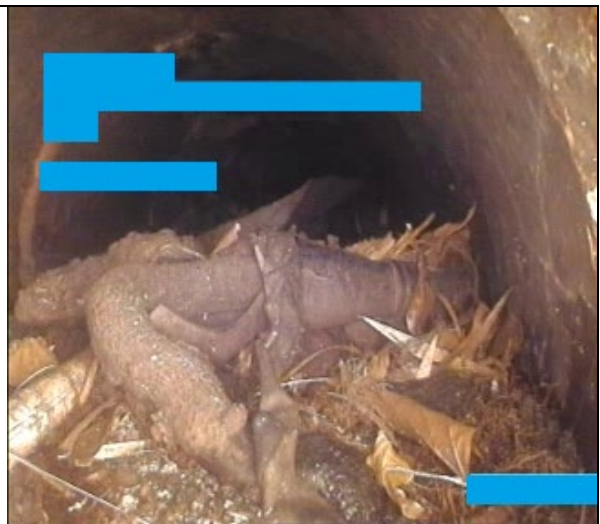
Stormwater Pipes in very poor condition – Tree root infiltrations and blocked

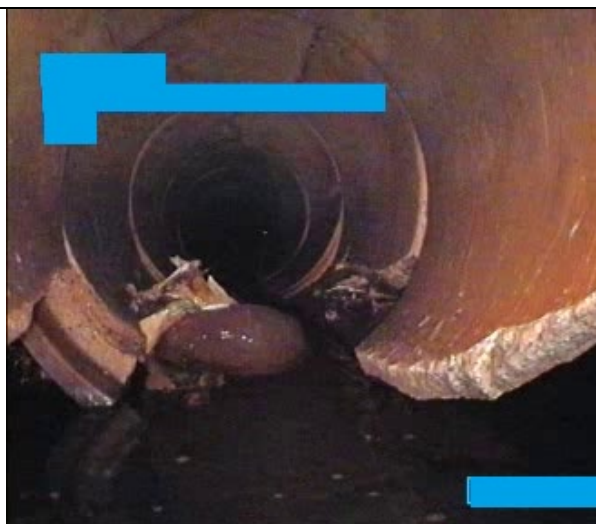
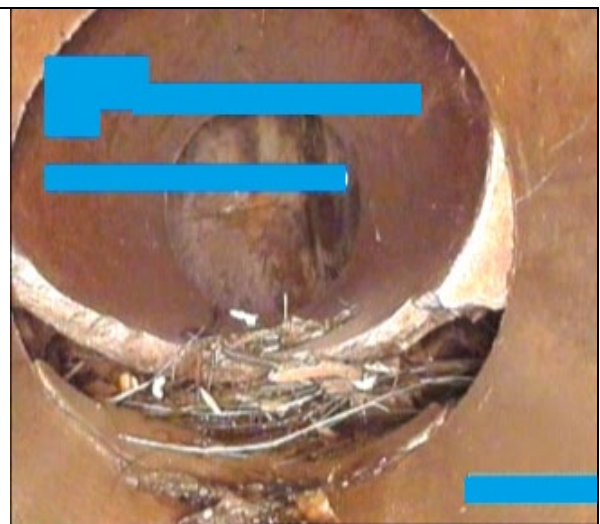
Stormwater Pipes in very poor condition – collapsed

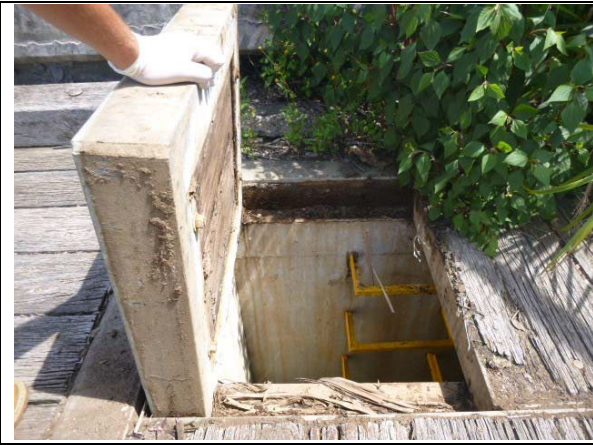
Lids are too heavy - The wood is starting to chip; they should be replaced. Lifting points rusted or broken off

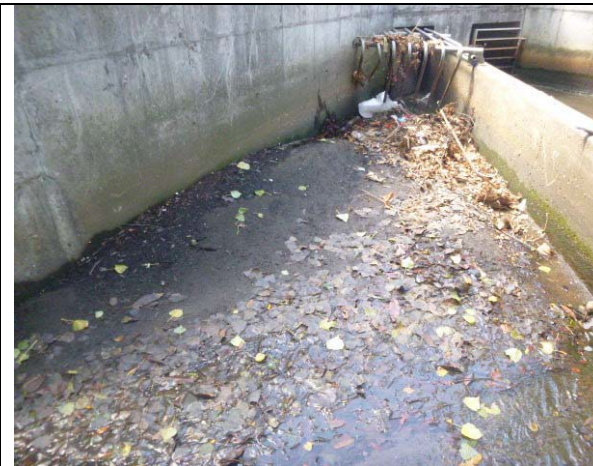
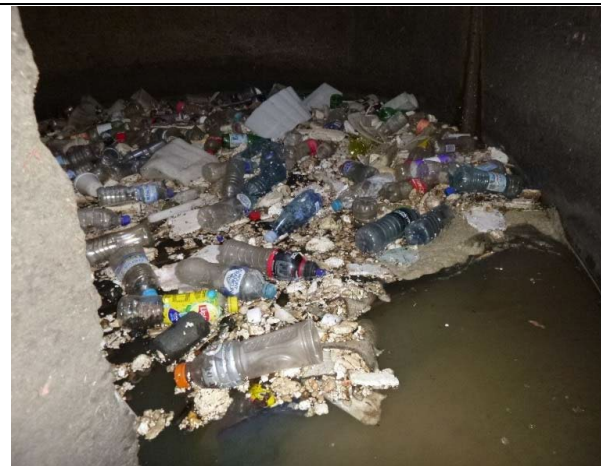
Sediment and trash build up in front of the weir and in pits generally – low capacity.

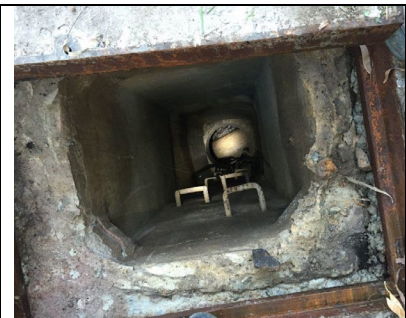
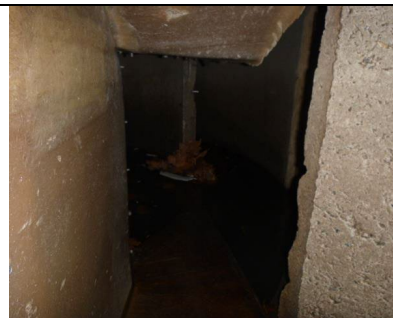
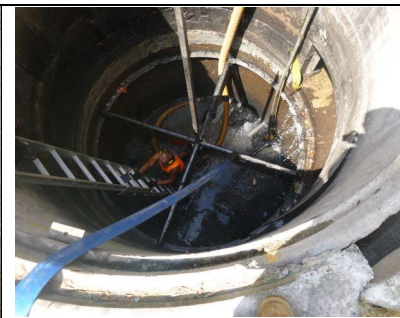
Difficult access to a lot of GPTs for maintenance

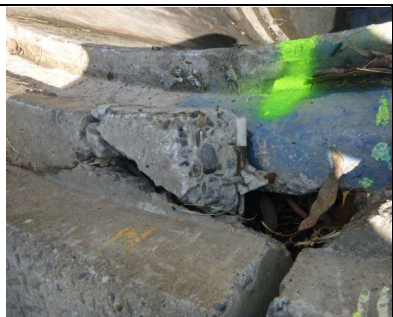
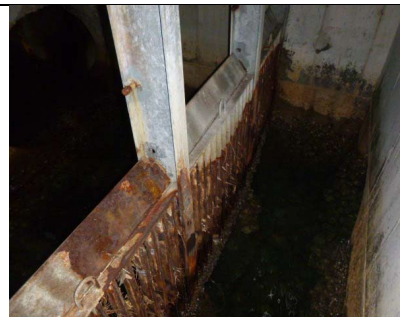
Corrosion and structural damage to GPT manhole covers
