10.16.Don Bank Museum Conservation Management Plan 2022

AUTHOR: Ian Hoskins, Historian

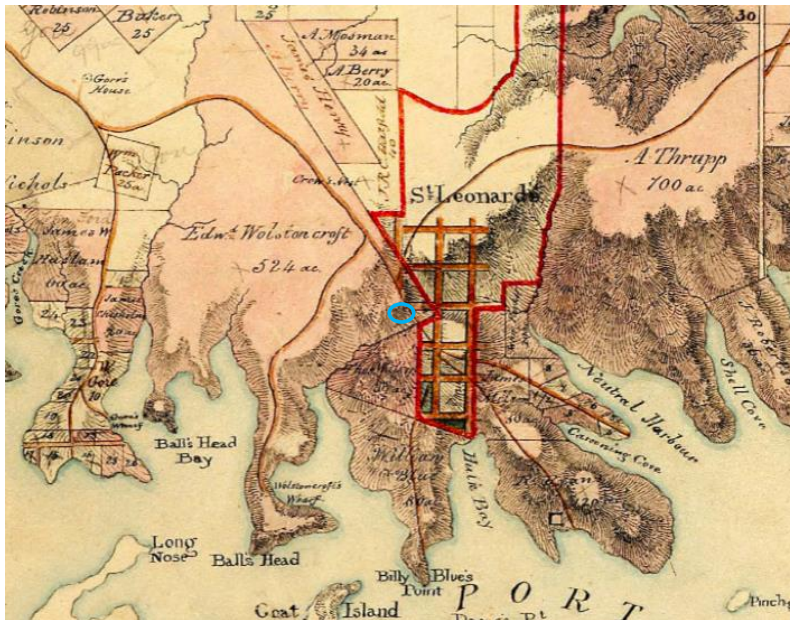
Figure 2. 1: Detail of an early (1830s) edition of the map of the parish of Willoughby within which is located North Sydney. It recorded the smaller land grants fringing the harbour shore and large grants made to Wollstonecraft (Wollstonecraft) and Thrupp. Don Bank is located within Wollstonecraft's grant of 1819 (approximate location is circled in blue). At the centre is the government township of St Leonard's gazetted in 1838, which today comprises much of the North Sydney CBD. Source: State Archives NSW (MAP 6205)

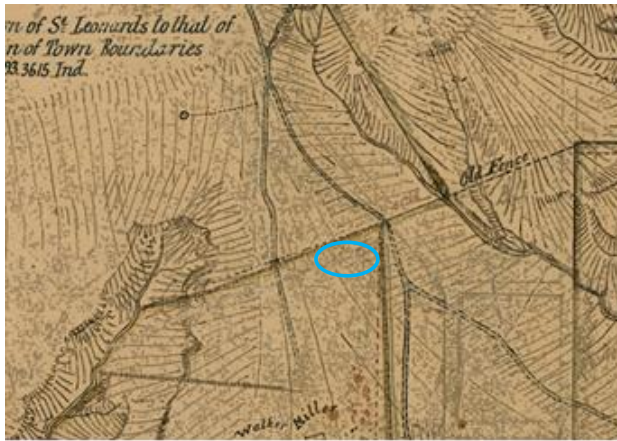
Figure 2. 11: Plan of the Government Reserve at the North Shire by Surveyor G Ogilvie, dated 1837. This survey recorded dwellings to the west of the new township. No development noted in the area of Don Bank (indicated with a circle). Source: NSW Land Registry Services (CP S.1015 (also SRNSW Map 5607))

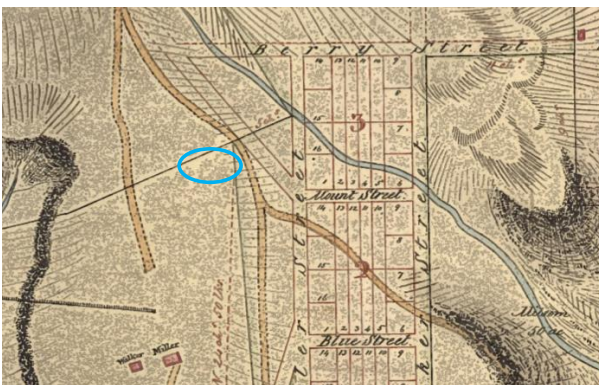
Figure 2. 12: Design plan of St Leonards by Deputy Surveyor General Perry, dated November 1838. This survey recorded dwellings to the west and east of the new township. No development noted in the area of Don Bank (indicated with a circle). Source: NSW Land Registry Services (CP S.1015b (also SRNSW Map 5609))

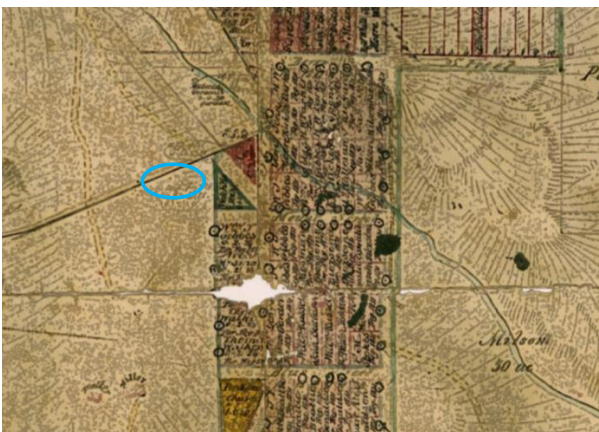
Figure 2. 13: Plan of St Leonards submitted for approval by Deputy Surveyor General Perry, dated June 1838. This survey recorded dwellings to the west of the new township. No development is noted in the area of Don Bank (indicated with a circle). Source: NSW Land Registry Services (CP S.1015a (also SRNSW Map 5608))

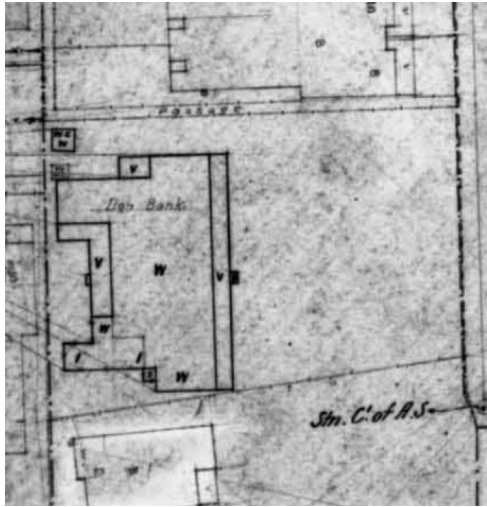
Figure 2.24: Detail of Sydney Water's North Sydney Sheet 27 dated 1892. This survey recorded the building footprint of Don Bank in 1890. The house name was noted as such, but this was a later annotation. It recorded an attached iron south wing, and the outside lavatory at the north-west corner, all later removed. Source: Sydney Water Archives (PWDS1544-S844)

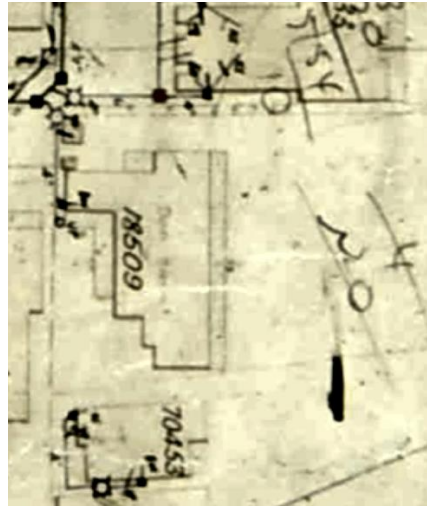
Figure 2.25: Detail of North Sydney Sheet 27, not dated but probably 1930. This revision of the survey of 1892 noted the removal of the attached iron south room. Service lines for the bathroom and kitchen, and the outside lavatory are shown. Source: Sydney Water Archives (BLKWTL606)

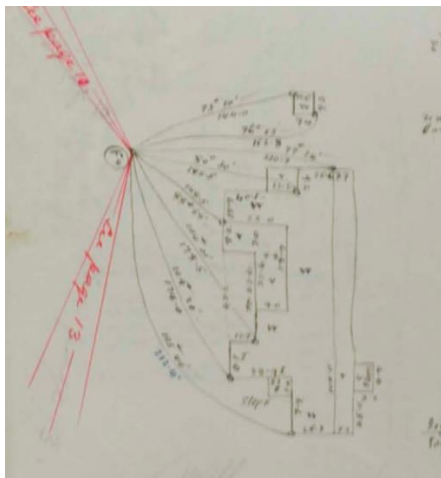
Figure 2.26: Extract from Surveyor TG Wilson's field book notes made in 1890 to prepare the survey reproduced in Figure 2.28. Source: Sydney Water Archives (Field Book 1762)

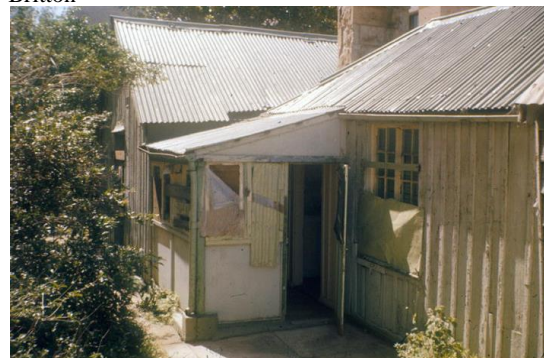
Figure 2. 43: A photograph by Beryl Graham of Don Bank in February 1976, and about 1&1/2 years after the death of Mrs Catherine White. Source: Stanton Library (CT11/36)

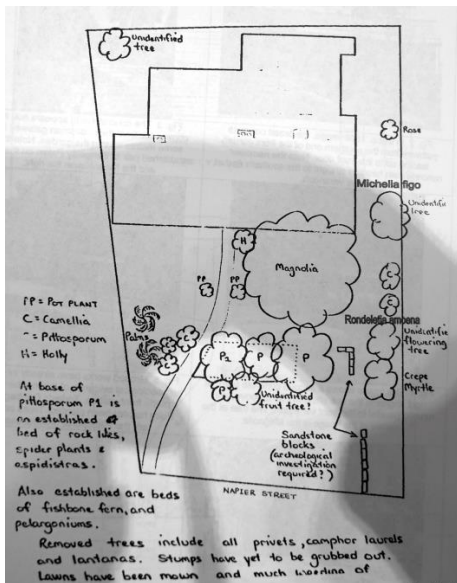
Figure 2.44: Sketch survey of the Don Bank garden at the time of the clean-up undertaken in 1979. Source: Reproduced in Mayne-Wilson & Associates, *Historical Landscape Analysis and Recommendations*, December 2007

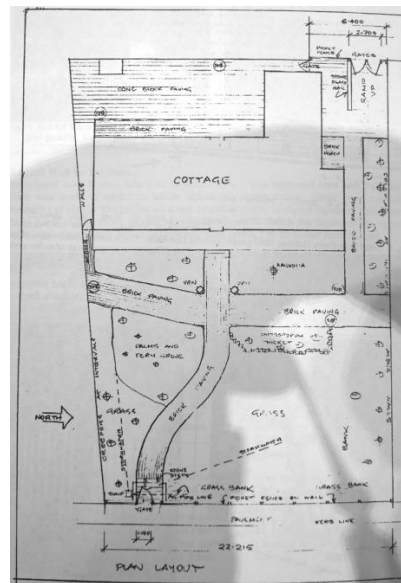
Figure 2.45: David Earle's proposed layout of the restored Don Bank garden dated 1980. This plan notes the installation of brick paving. Source: Reproduced in Mayne-Wilson & Associates, *Historical Landscape Analysis and Recommendations*, December 2007

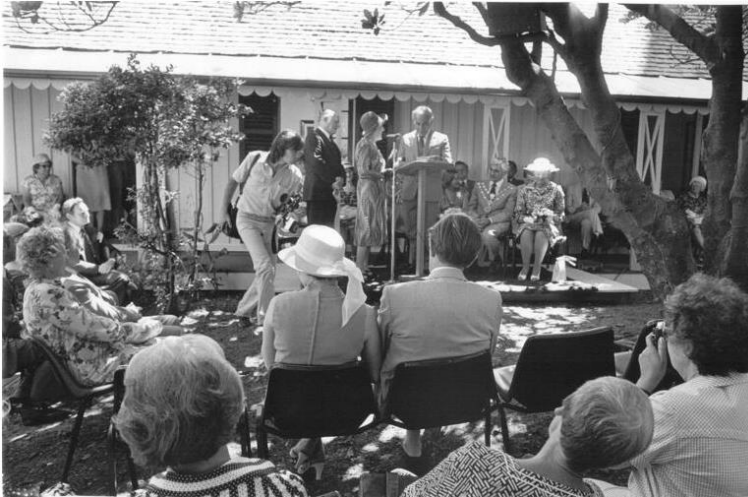
Figure 2. 52: Governor General Sir Zelman Cowan officiating the opening of the Don Bank Museum in 1981. Source: Stanton Library (LH Ref 3427)

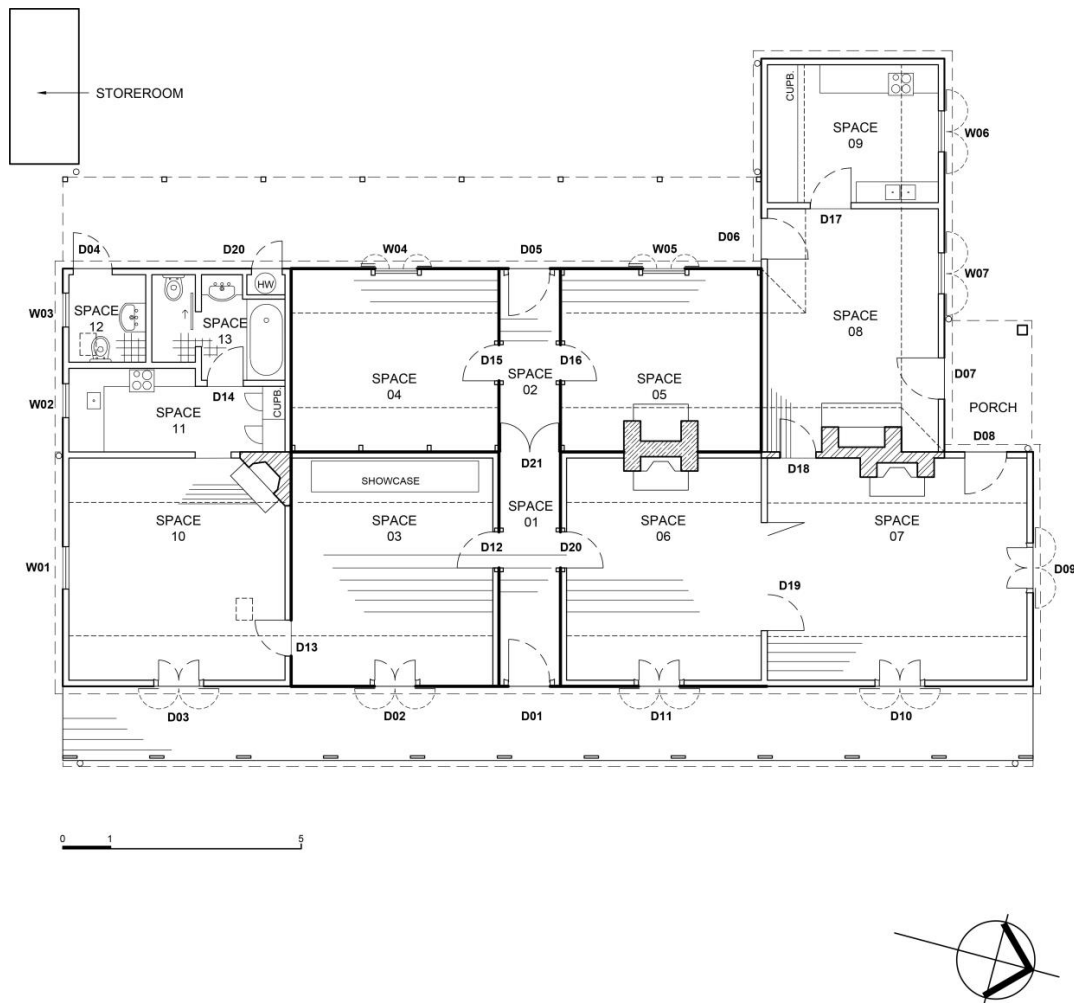
Figure 3. 29: Don Bank Floor Plan as existing, LSJ, 2022

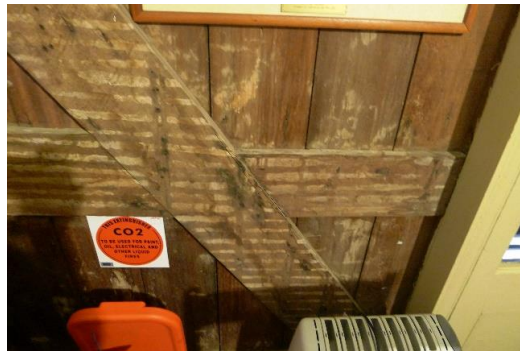
Figure 3. 71: Rails and boards in Space 03 with butt joints and evidence of lath and plaster.

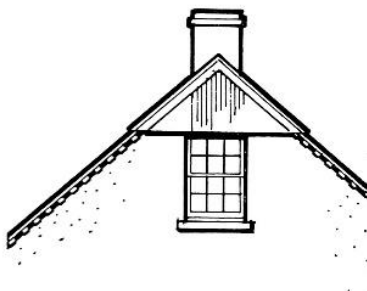
Figure 3. 75 (above): Diagram of a Jerkin head roof form.
Source: Stapleton, I., *How to Restore the Old Aussie House*, The Flannel Flower Press, 1983; p. 33

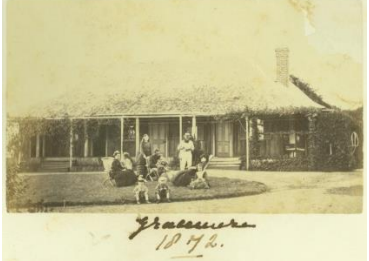
| Item | Description | Image |
|---|---|--|
| <p>Gracemere Homestead, Gracemere, Rockhampton region, Queensland</p> <p>Queensland State Heritage Register (No. 600508)</p> | <p>Constructed in c1858/59 by Colin Archer as a two-room house clad in split vertical ironbark slabs, lined internally with vertical cedar boards. In about 1869 a wing was added constructed of vertical sawn beaded boards of Burdekin Plum.</p> | <p>Figure 4. 10: Gracemere homestead in 1872. Source: Wikipedia</p> |

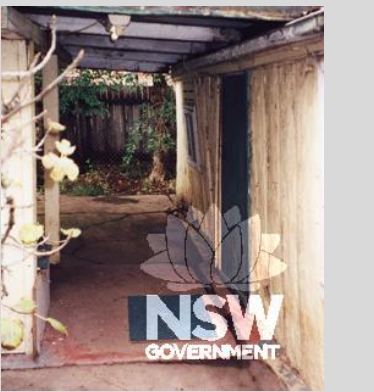
| Item | Description | Image |
|--|---|---|
| <p>Sharman's Slab Cottage, Harrington Park, NSW</p> <p>Local heritage item (No. I121)</p> | <p>A late 19th century slab cottage, a rare example of a worker's cottage of the time. The one family lived in this cottage continually for over 70 years, with boxing promoter Jimmy Sharman being born there in 1887. The cottage is clad in vertical timber slabs, with a corrugated metal gabled roof.</p> | <p>Figure 4. 15: Detail of front elevation. Source: NSW Heritage</p> |

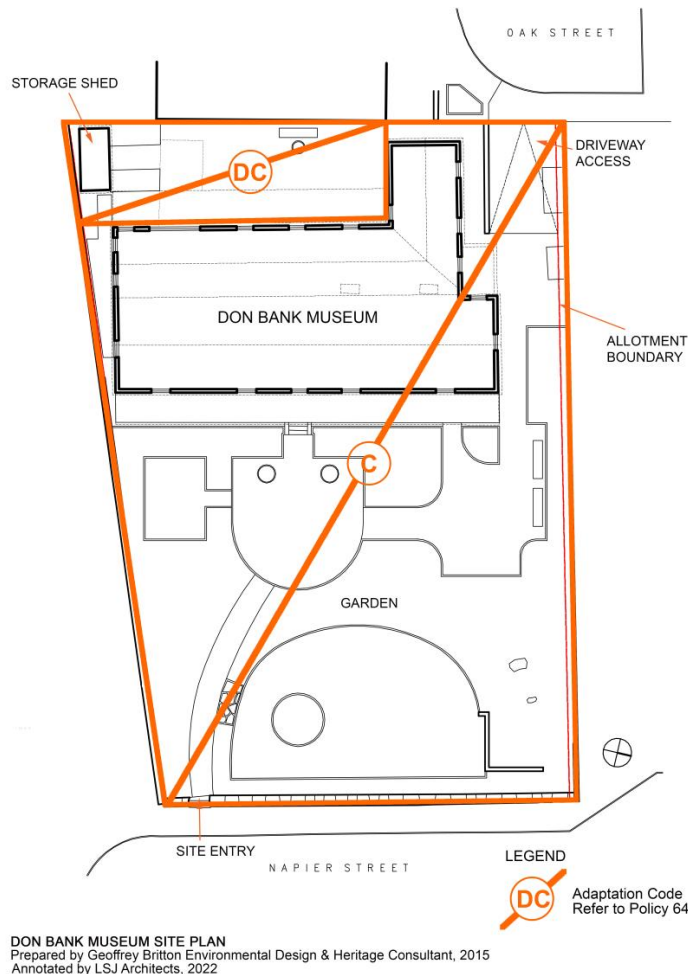
Figure 7. 1: Site adaptation plan

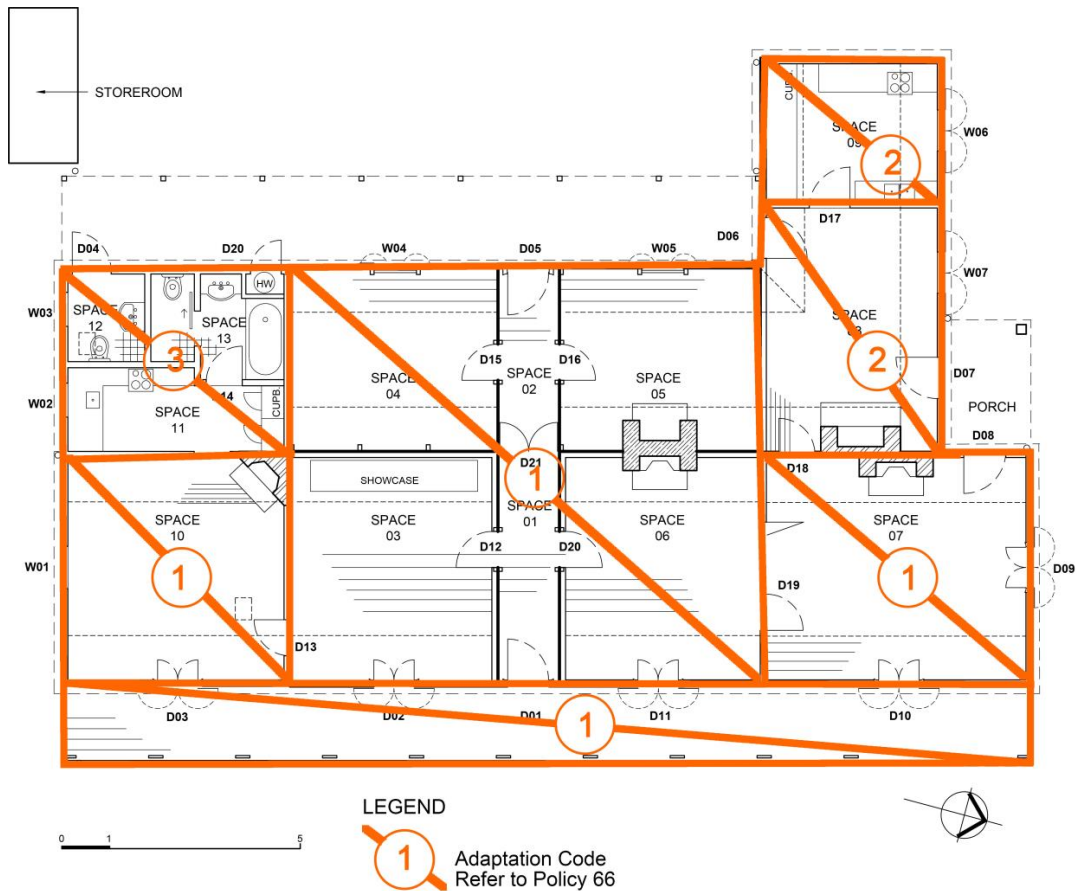
Figure 7. 2: Ground floor level interior adaptation plan

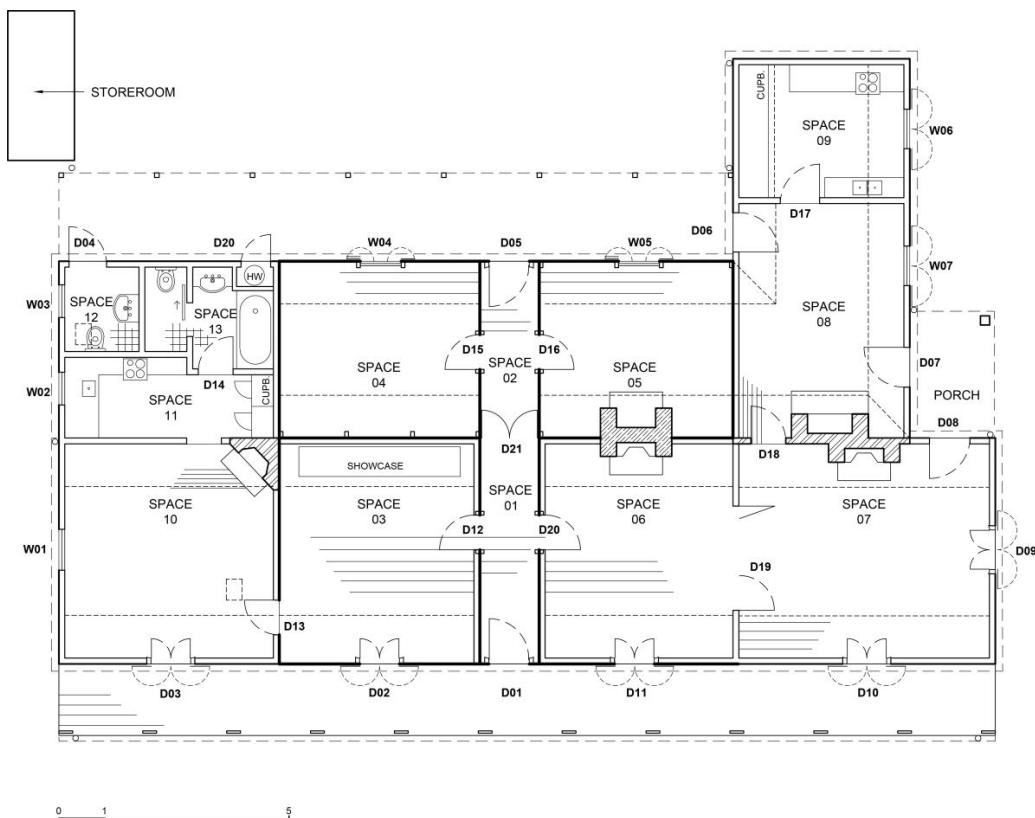
| Space/ Element | Description | Condition | Date | Significance Ranking |

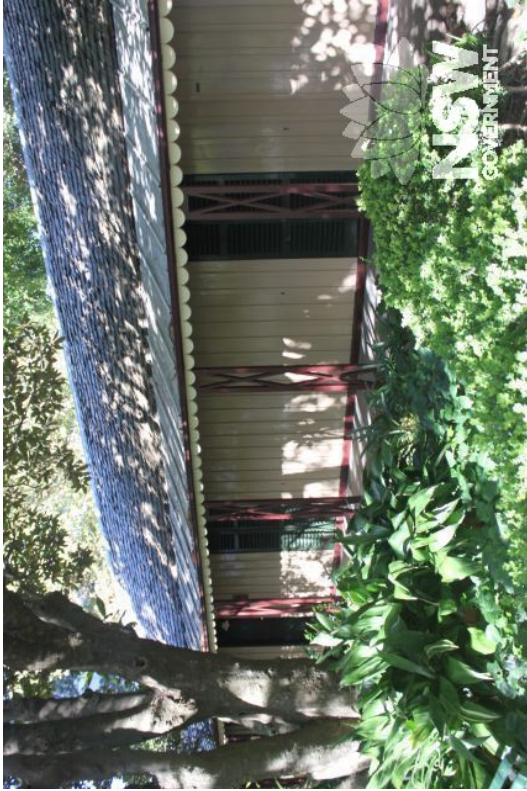
12/01/2022 09:22 AM 10 of 12

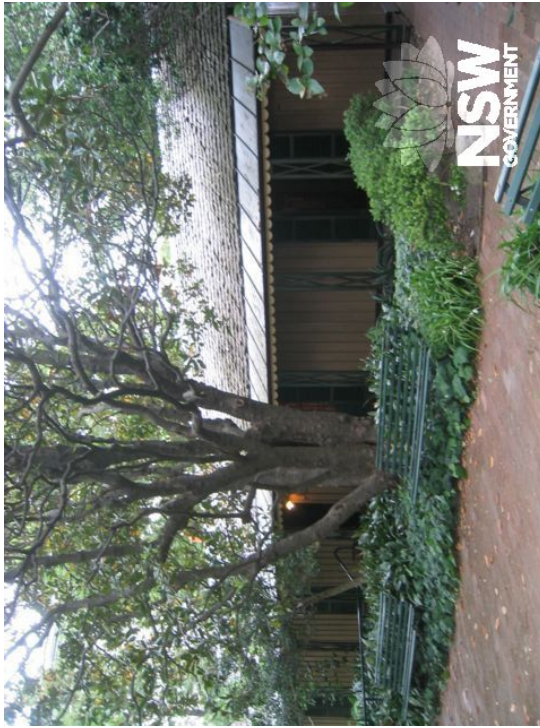
12/01/2022 09:43 AM 5 of 6
