Report to General Manager

SUBJECT: SP 11620, 30a Lavender Street, Lavender Bay – Fig Tree Removal

AUTHOR: Melanie Hamilton, Tree Preservation Officer

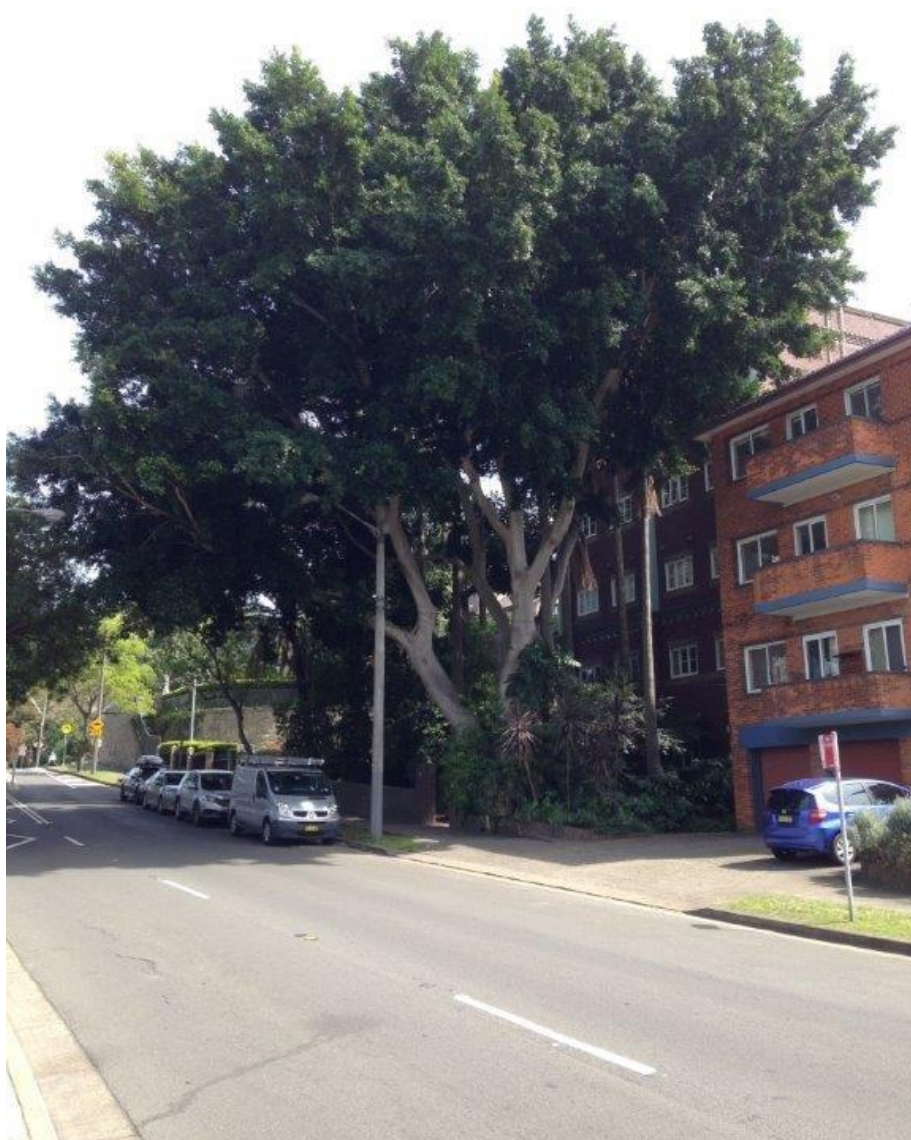
The *Ficus microcarpa* (var.hilii) Hills Fig tree is located in the South-East corner of 30a Lavender Street, Lavender Bay. It is 27 metres in height with a 30 metre canopy spread that overhangs the front yard of the property and Lavender Street traffic lanes. The tree is a mature specimen and in healthy condition with 90% foliage cover.

The Hills Fig tree was planted within the last 40 years in front of the Palm trees and is poorly located in shallow soils for such a large tree species. The Fig Tree is located adjacent to underground services (gas lines) and is causing structural damage with its root system to boundary walls, pathways and the neighbouring driveway.

The Arborist report notes that without a physical barrier to deter root growth, roots will inevitably grow and cause damage to surrounding structures. Tree roots up to 150mm diameter were observed causing damage and pruning roots of this size within the critical root zone to manage and rebuild structural faults will cause the trees health and stability to decline.

As it is very likely that any remedial works will be damaged by expanding roots and there is no realistic way of managing a tree of this magnitude in its current location, it is recommended that the tree be removed.
