## ADDENDUM TO REPORT OF OF KATERINA PAPAS, SENIOR STRATEGIC PLANNER

**SUBJECT:** 9.9 Planning Proposal 1/26 – 27-37 Bydown Street, Neutral Bay

# 27-37 Bydown Street, Neutral Bay

Comparative Analysis and Heritage Assessment

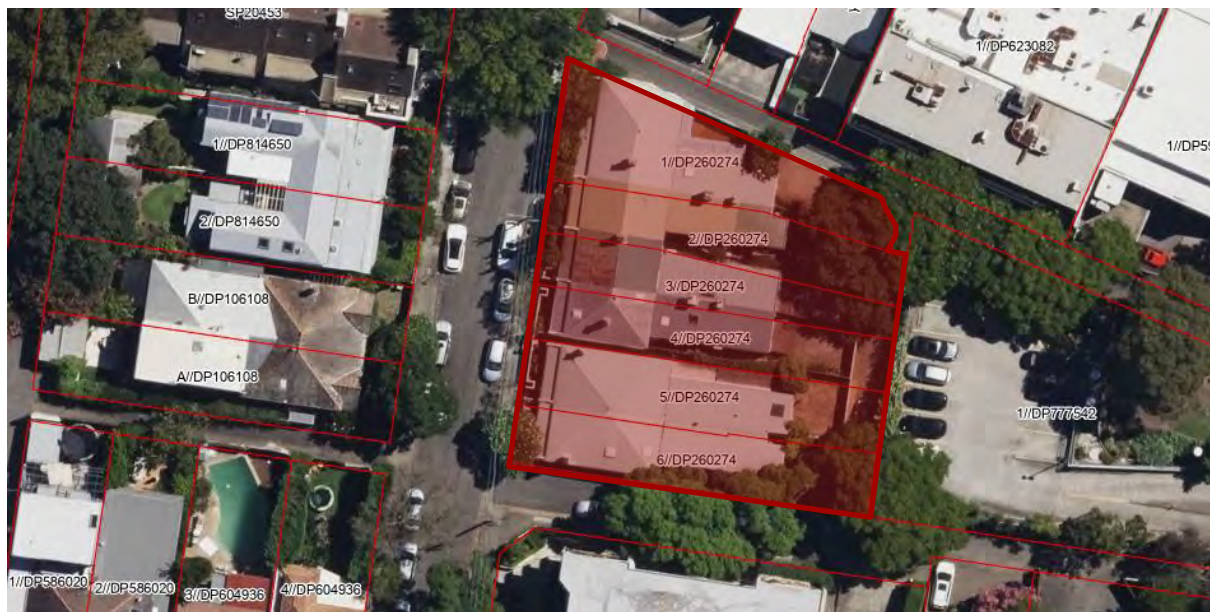
Figure 1 Aerial photograph showing Lot and DP of the subject properties (shaded in red). (Source: NSW Planning Portal Spatial Viewer.)

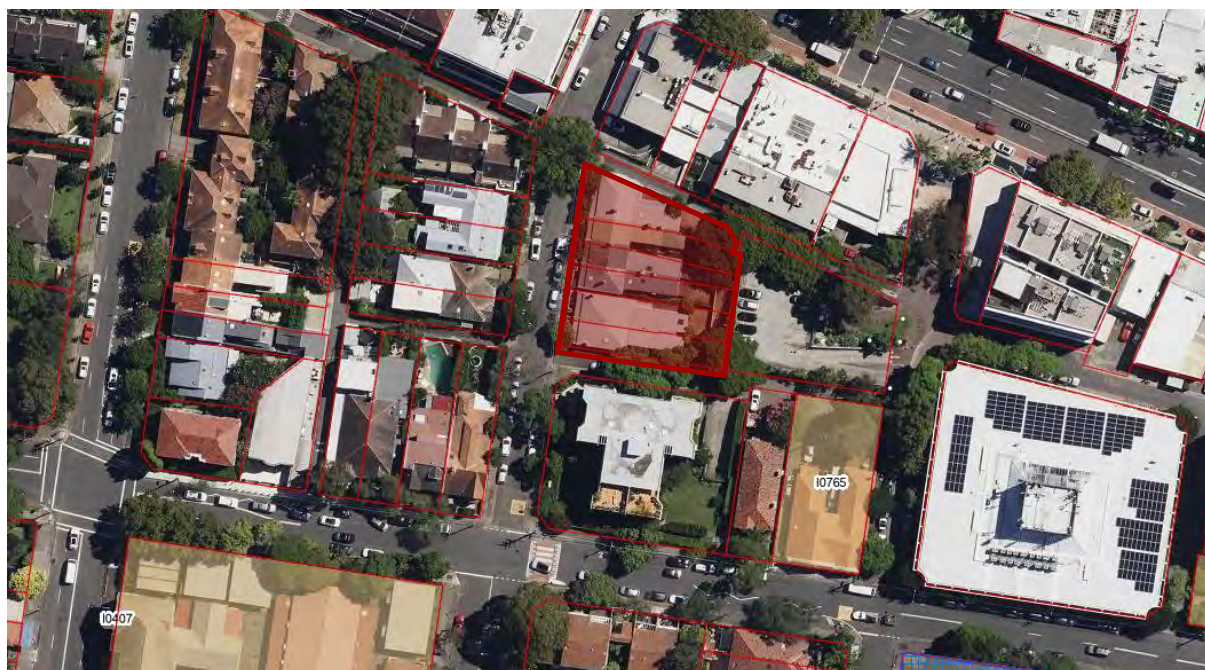
Figure 2 Aerial photograph showing subject properties (shaded in red) and heritage items in the vicinity (shaded in brown). (Source: NSW Planning Portal Spatial Viewer.)

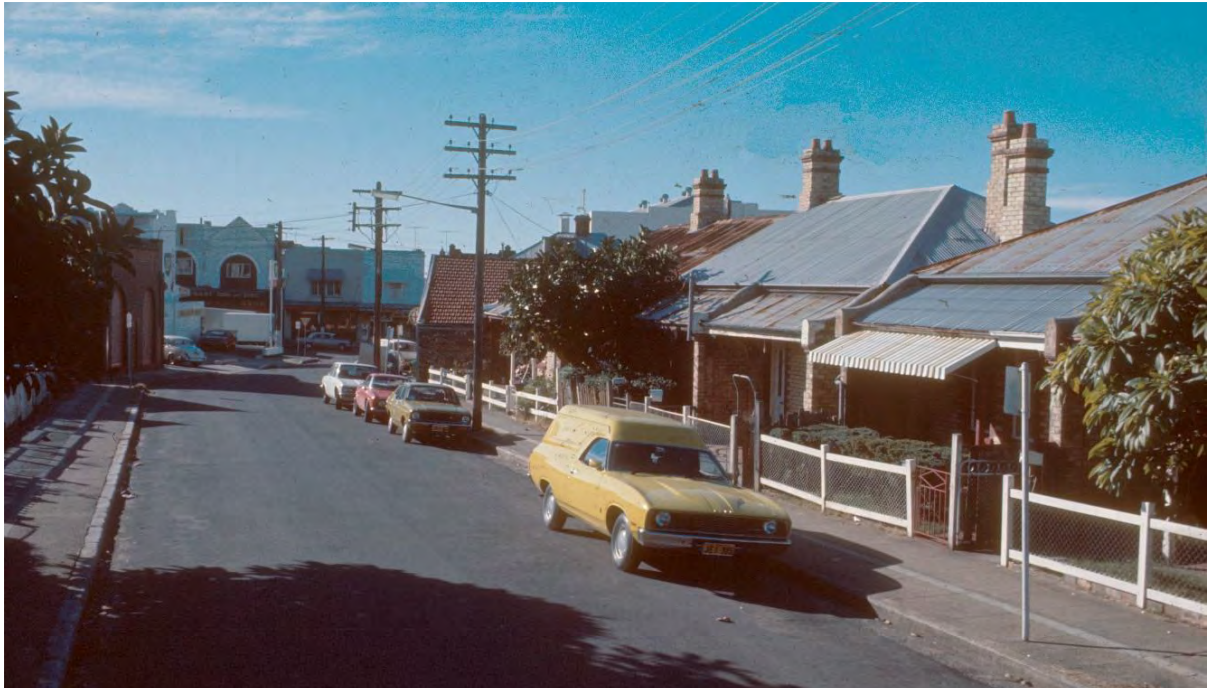
Figure 3 1970s photograph of the subject properties (looking north towards Military Road) – before the construction of the 1.8m front fence across all the properties. (Source: Stanton Library, Call Number: LH REF CT 154/2.)

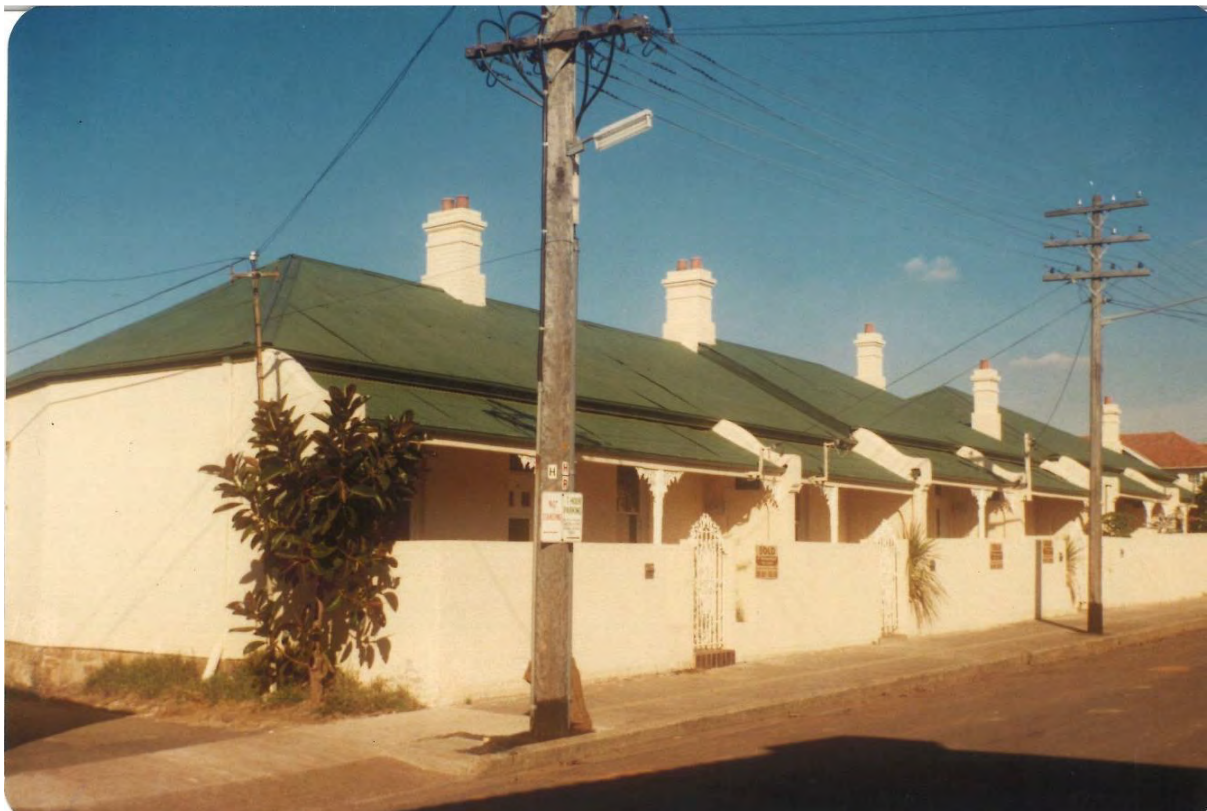
Figure 4 1980 photograph of the subject properties (looking south with No. 37 in the foreground) – after the construction of the 1.8m front fence across all the properties, roof changed and brick painted. (Source: Stanton Library, Call Number: LH REF CT 12/8.)

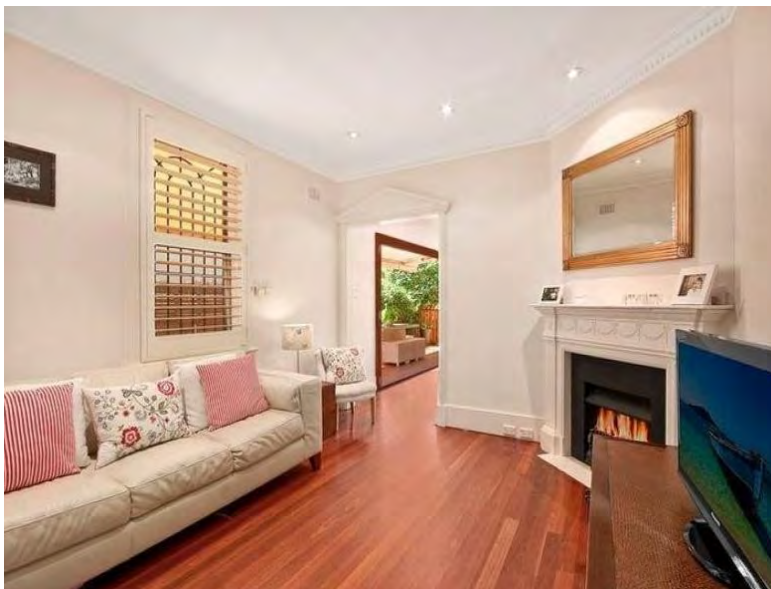
Figure 8 *Photograph of the living room from February 2012. Note, fireplace no longer exists. (Source: <https://www.realestate.com.au/property/29-bydown-st-neutral-bay-nsw-2089/>)*

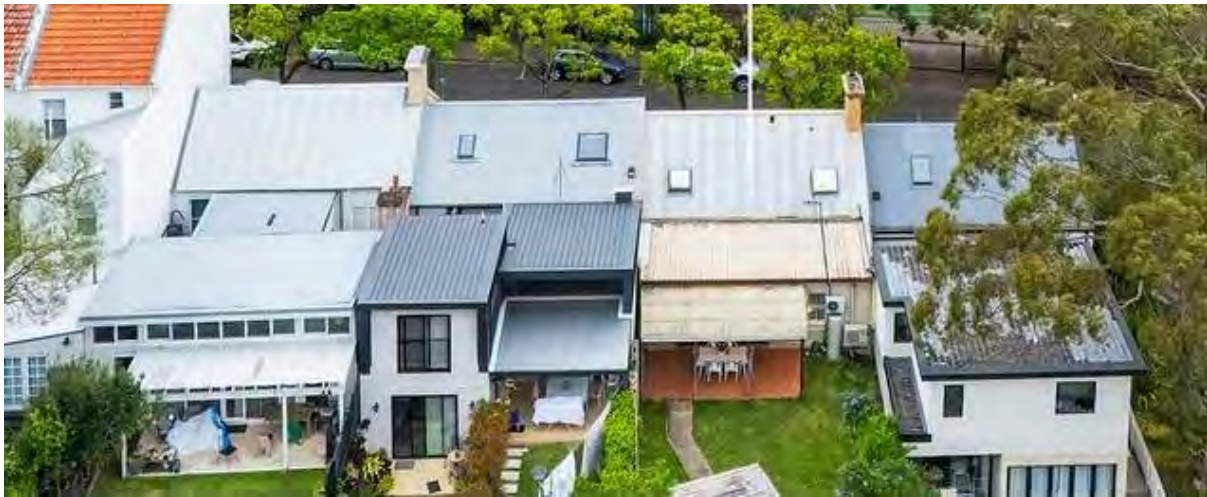
Figure 16 *Aerial photograph of the Lord Street properties showing alterations and additions to the rear.*  
(Source: <https://www.realestate.com.au/property-house-nsw-north+sydney-149338208>)

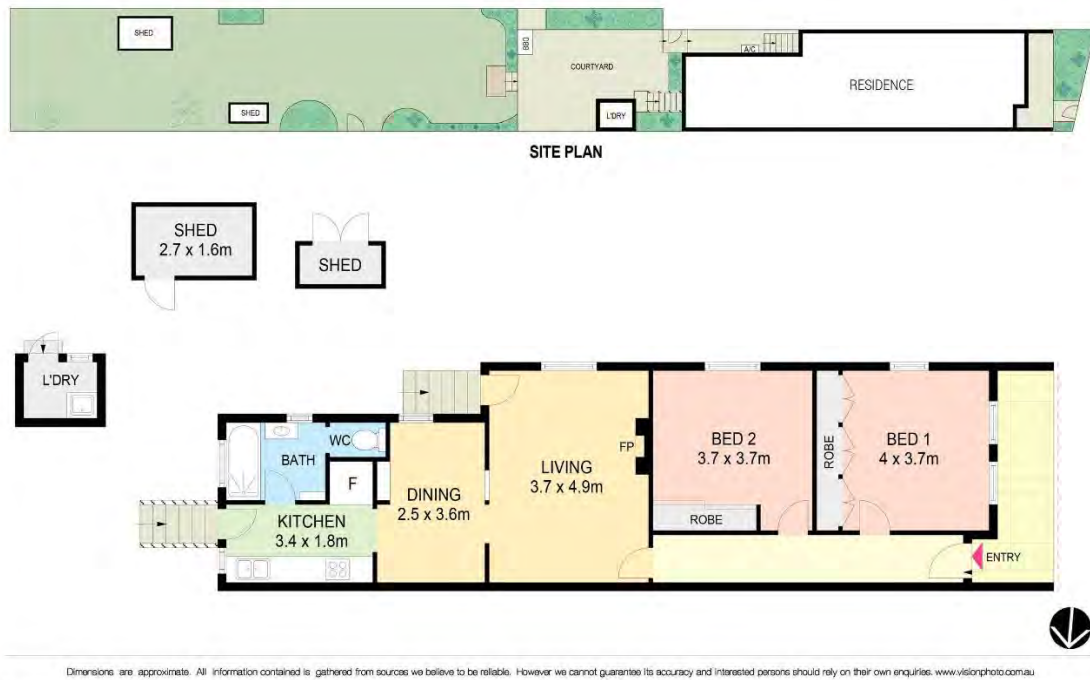
Figure 17

*Floorplan of No.45 Ben Boyd Road showing similar internal configuration to No. 31 to 35 Bydown Street. (Source: <https://www.realestate.com.au/property/45-ben-boyd-rd-neutral-bay-nsw-2089/>)*
