NORTH SYDNEY COUNCIL

ASSET MANAGEMENT PLAN

ROADS ASSET CLASS

2025/35

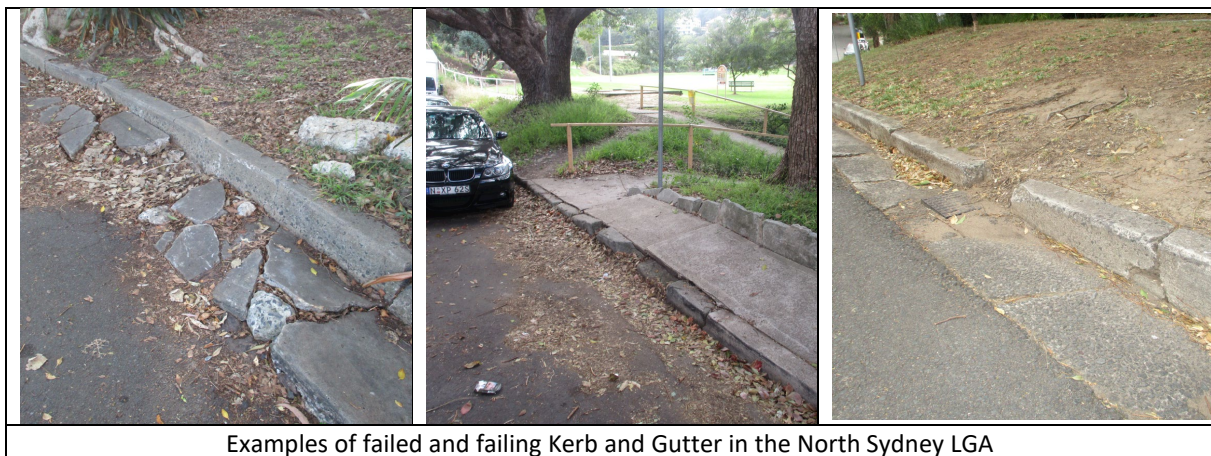
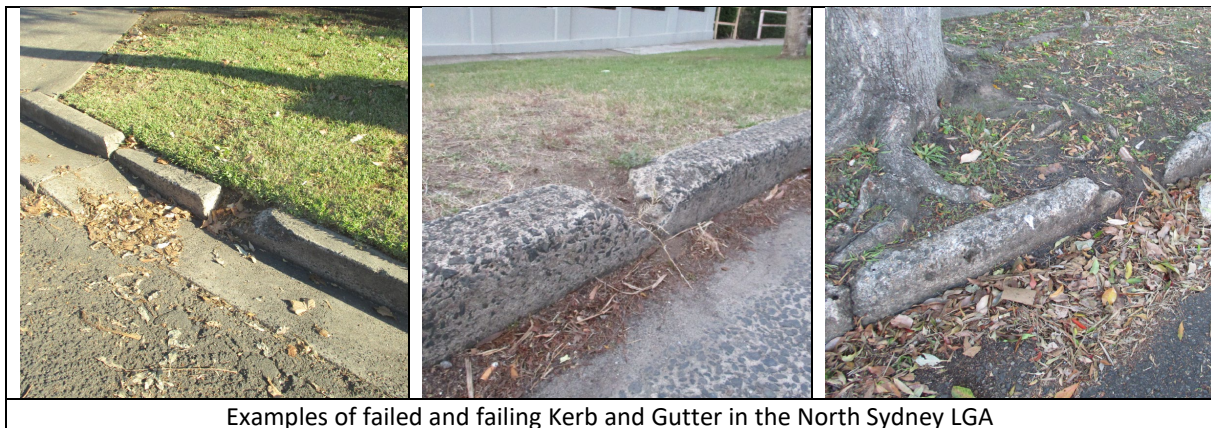
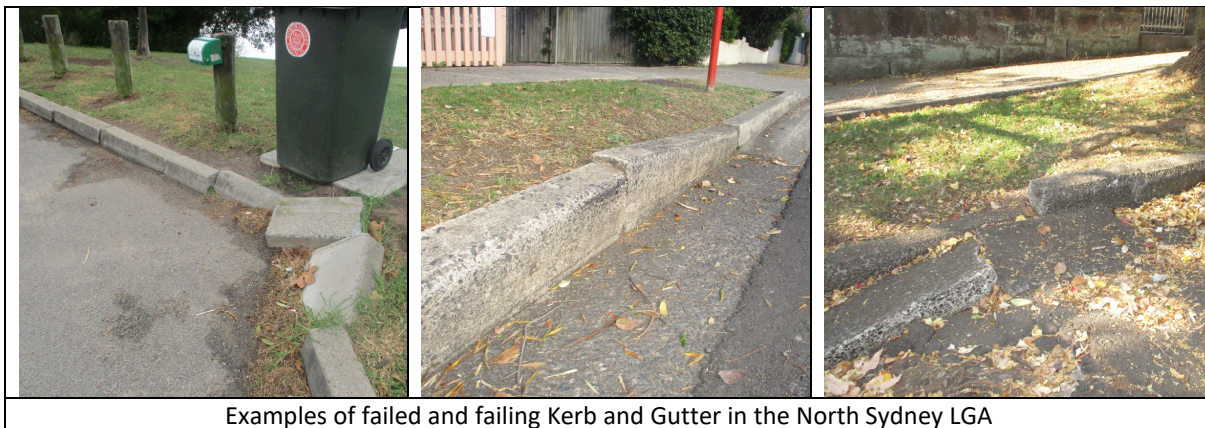
6.2 Examples of Kerb and Gutter risks in the North Sydney LGA.

Examples of failed and failing Kerb and Gutter in the North Sydney LGA

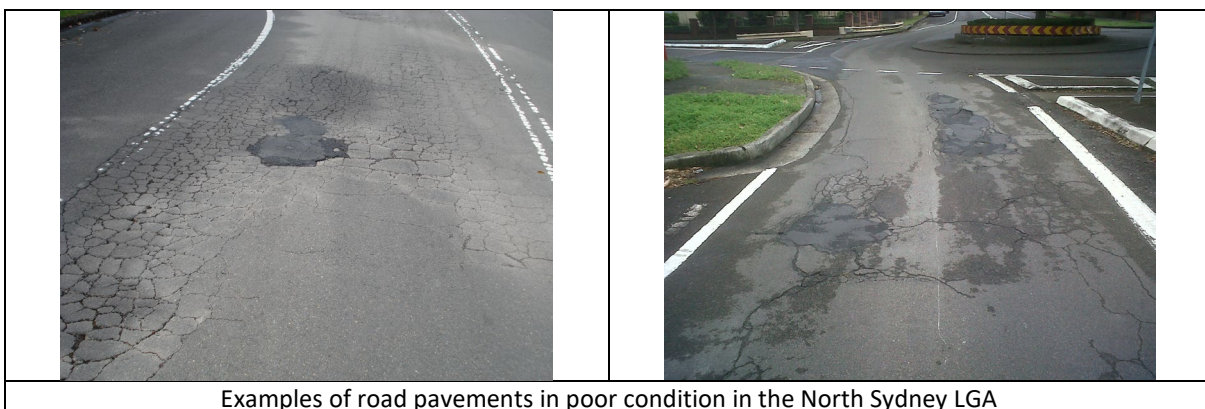
Examples of road pavements in poor condition in the North Sydney LGA

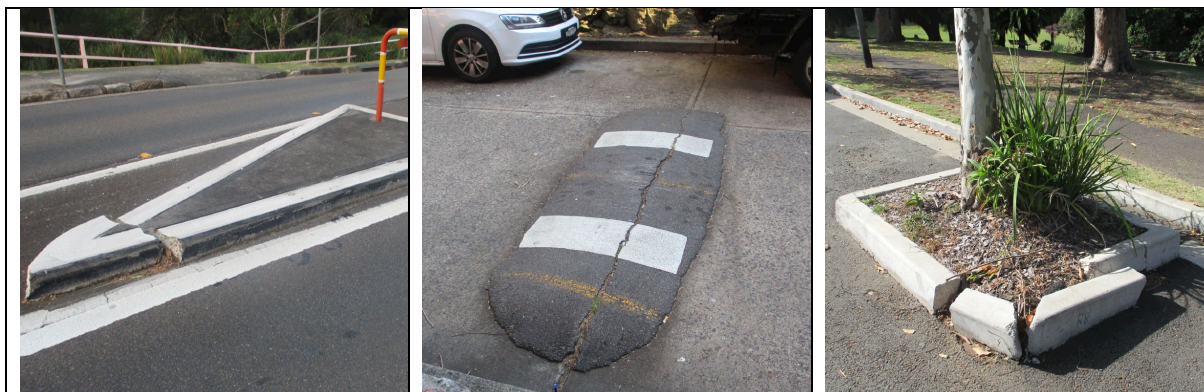
Examples of failed and failing Traffic Facilities in the North Sydney LGA

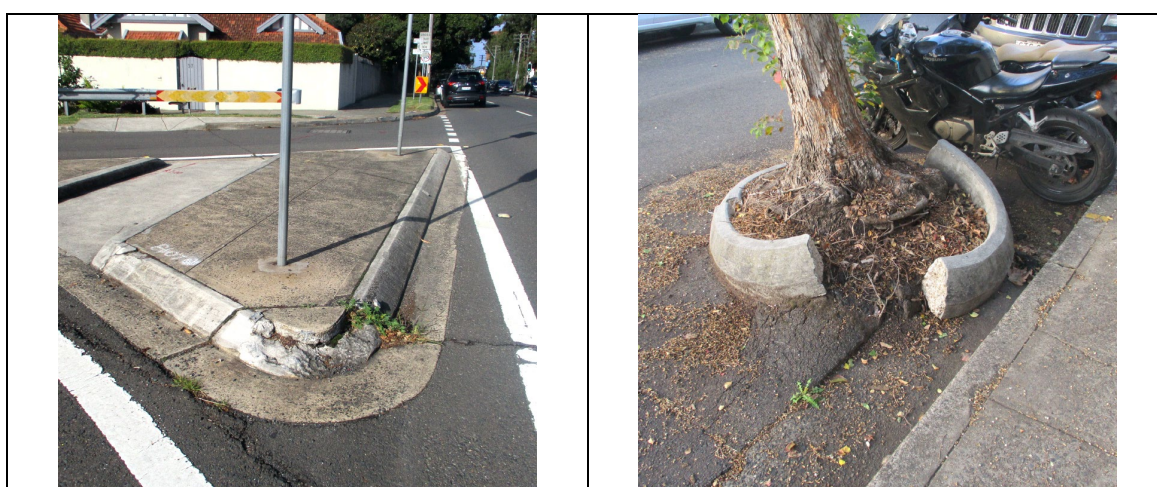
Examples of failed and failing Traffic Facilities in the North Sydney LGA

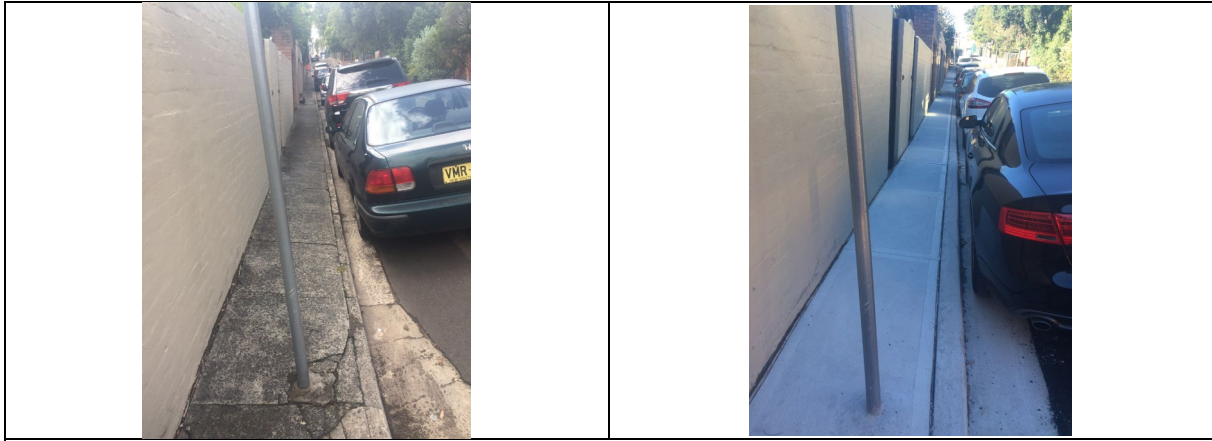
Kerb and Gutter, Crescent Place, Kirribilli – Before and After

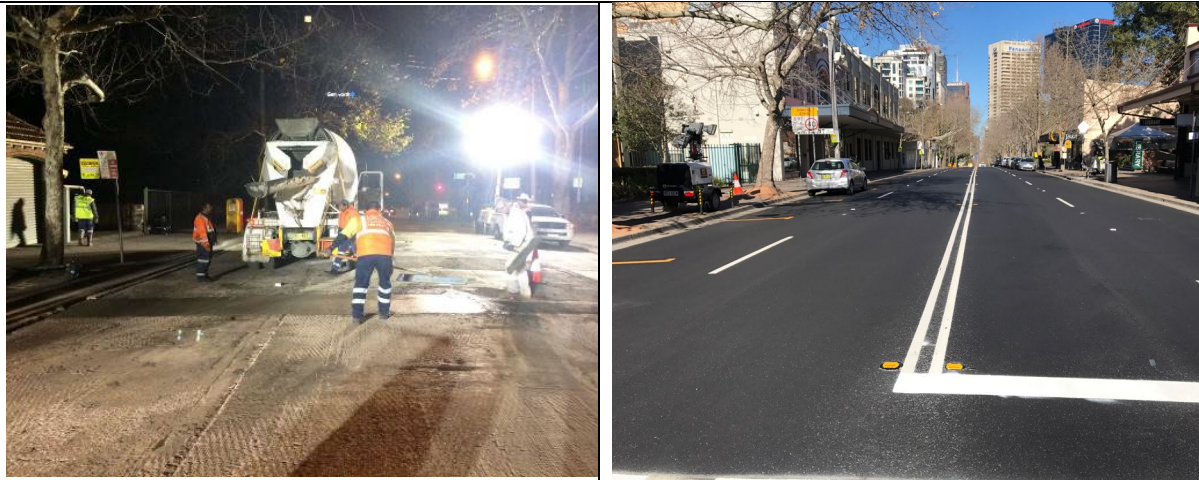
Road Pavement - Miller Street, North Sydney, before and after

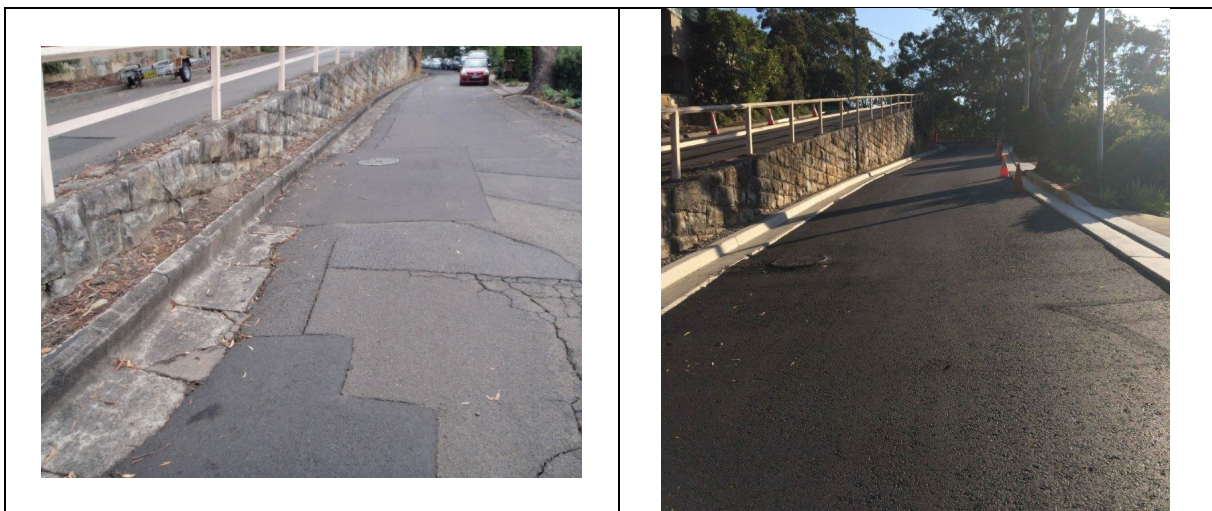
Road Pavement - Folly Point, Cammeray, before and after

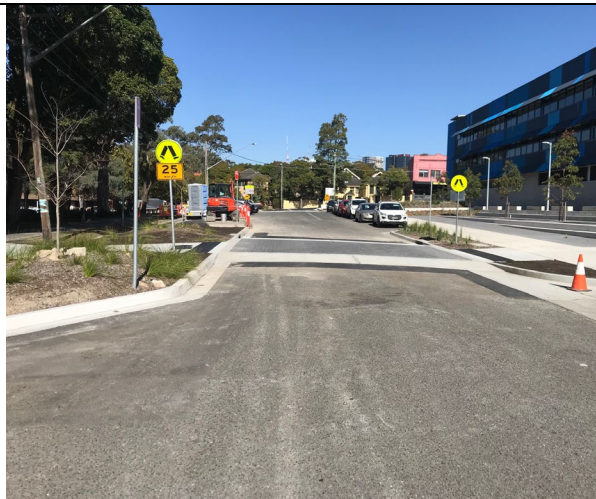
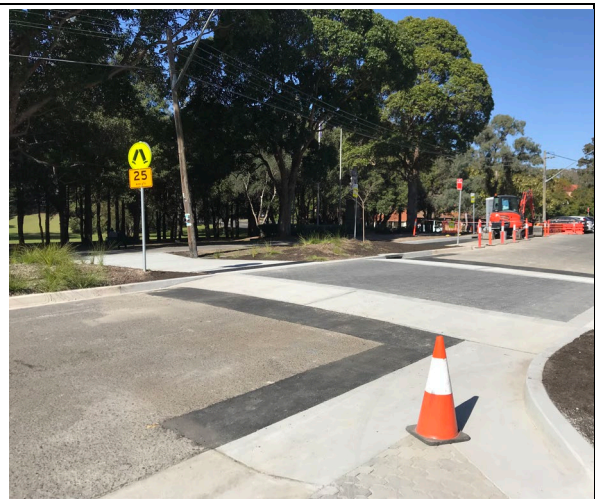
Traffic Facilities - Pedestrian Crossing – Anzac Avenue, Cammeray

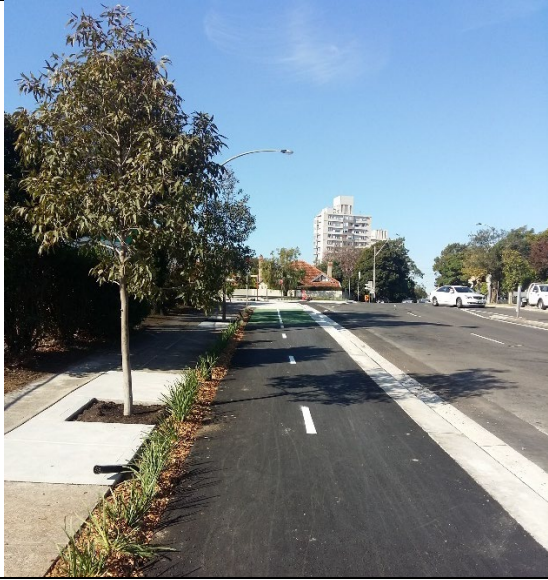
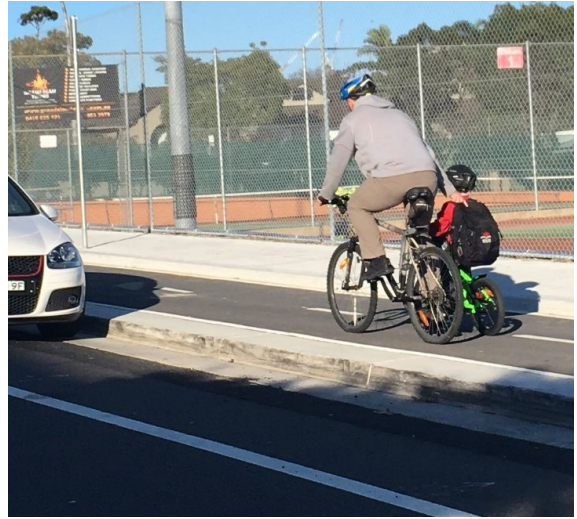
Traffic Facilities - Bi-directional separated cycle path on Ernest Street/Park Avenue
