**Item 4.3 - Traffic - 19/03/21**

**SUBJECT:** (4.3) Minor Traffic Investigations

**MINOR TRAFFIC INVESTIGATIONS**  
**538<sup>th</sup> TRAFFIC COMMITTEE - 19 MARCH 2021**

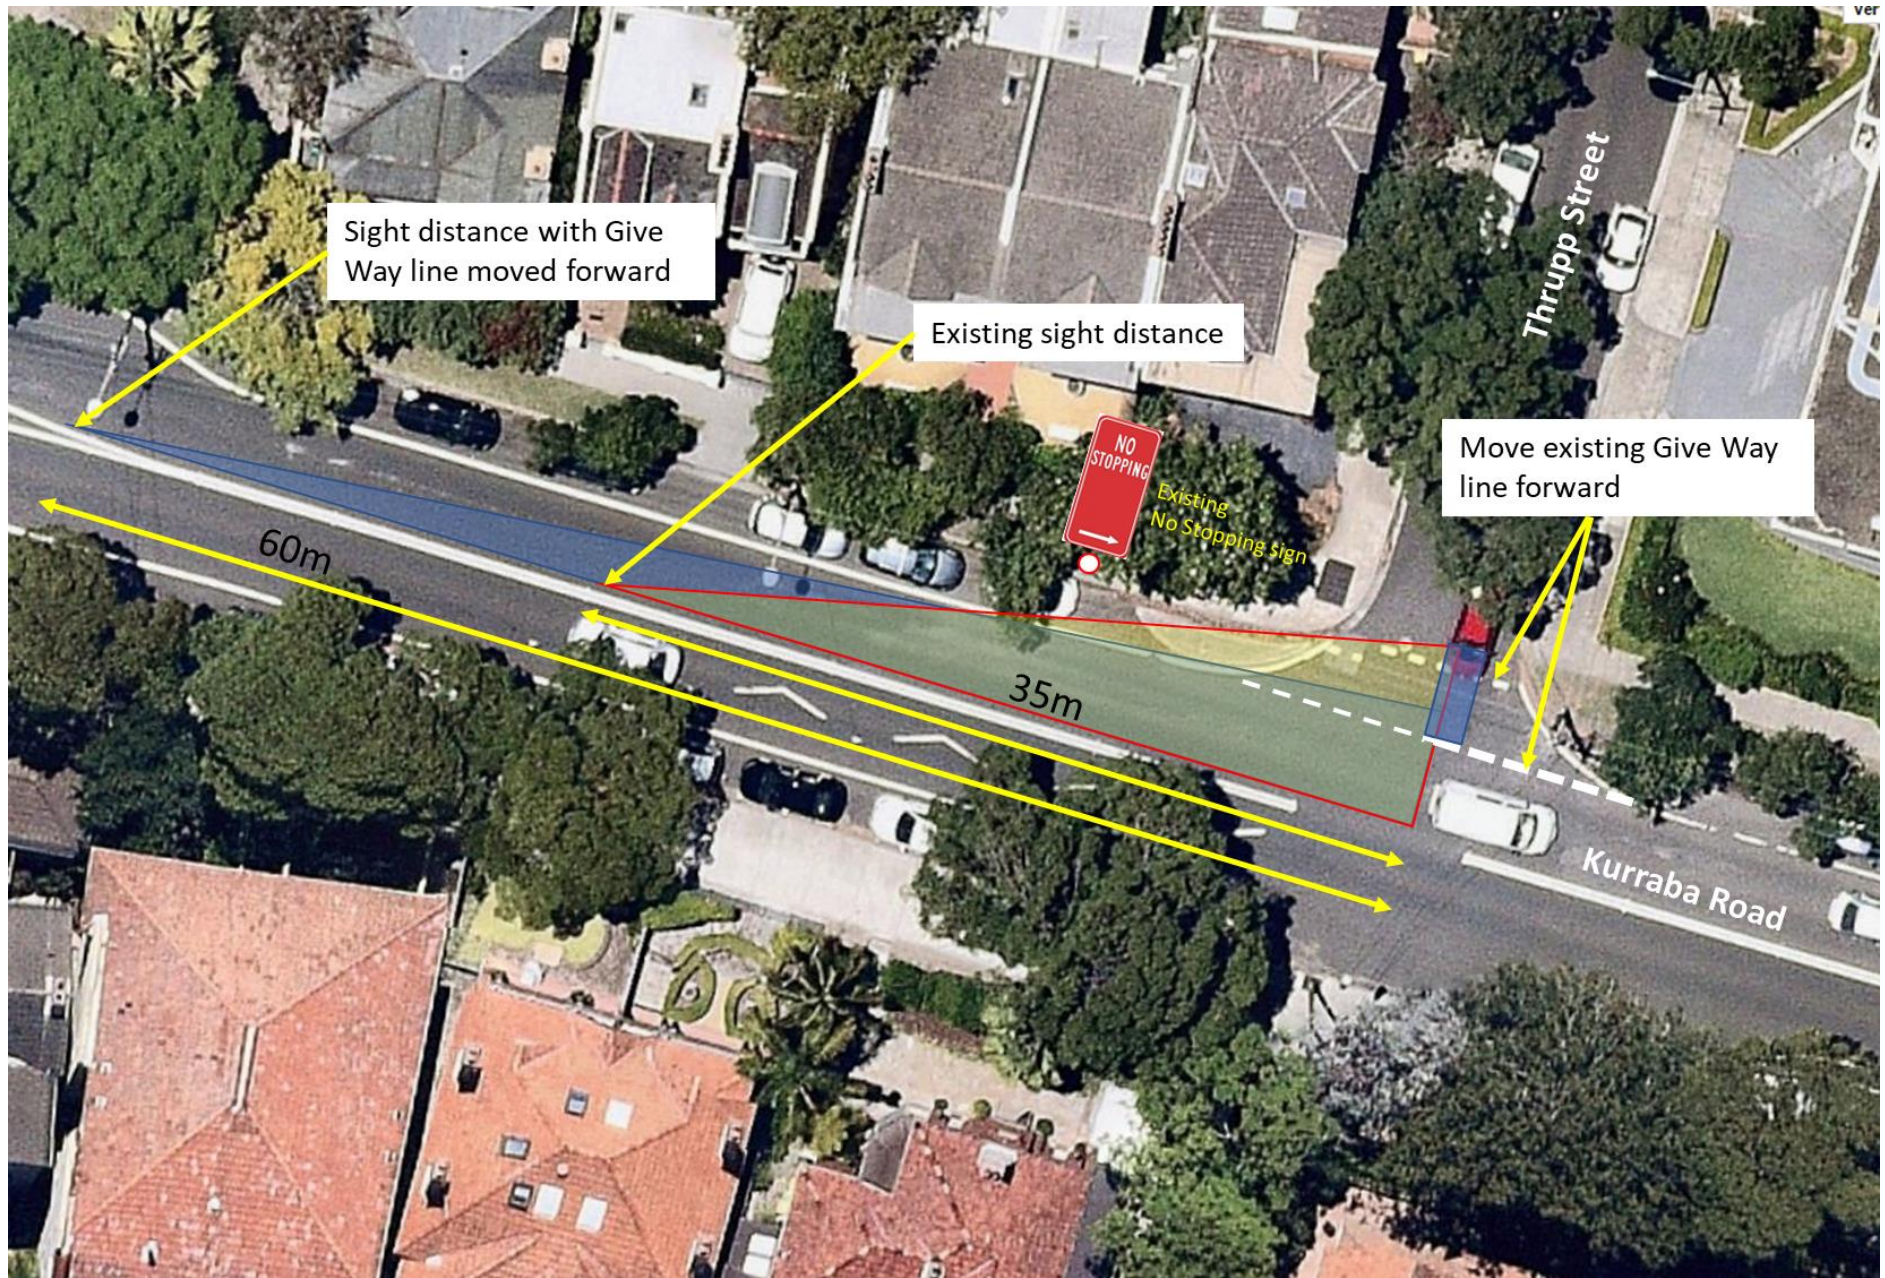
# Thrupp Street at Kurraba Road – Proposed Giveway Line Adjustment

Street/ Location	Precinct, Ward,	Issue/ Request	Investigation	Recommendation	Signs & Lines Priority	Standard/ Guideline	ECM
				<p>With regard to the request for the kerb blister extension at the intersection of Kurraba Road and Thrupp Street, the existing kerb blister on Kurraba Road has been installed for a distance of 10m west from Thrupp Street. Further extension will result in the removal of on street parking space.</p> <p>A review of the crash history revealed no recorded crash at the intersection of Kurraba Road and Thrupp Street.</p> <p>It appears that the available sight distance from Thrupp Street to Kurraba Road is approximately 35m slightly less than the minimum sight distance requirement of 45m according to the Australian Standards. It may be appropriate to move the existing Give Way line forward allowing motorists to achieve a maximum sight distance of approximately 60m. Refer to attached plan.</p>

Street/ Location	Precinct, Ward,	Issue/ Request	Investigation	Recommendation	Signs & Lines Priority	Standard/ Guideline	ECM
			<p>existing concrete blisters on the corner of Kurraba Road and Thrupp Street be extended to improve sight distance.</p>	<p>The 50<sup>th</sup> percentile and 85<sup>th</sup> percentile speeds were recorded at 29km/h and 37km/h respectively which are within the 50km/h default urban speed limit.</p> <p>Based on the traffic count results, the traffic volume in Thrupp Street is not considered excessive for a local road.</p> <p>A review of the most recent five-year crash history from TfNSW revealed no recorded crashes in Thrupp Street. This indicates that drivers are generally aware of the road conditions and adjust their behaviour accordingly.</p> <p>Based on the recorded low traffic volume and speed and the lack of crash history, it is difficult to justify the necessity for the one-way flow.</p> <p>The benefits of two-way configuration are that, flexibility is retained for all users, alternative option is available if street is temporarily blocked at one end, speeds are generally lower due to the presence (or expectation) of opposing traffic, signage is minimised, motorists expectations are better met etc.</p> <p>One-way configuration, conversely, can have the following detrimental effects: speeds are often higher, flexibility in choice of direction is removed, adjacent streets get a greater loading of traffic, numerous signs need to be installed and maintained.</p> <p>The other suggested option for a permanent closure of Thrupp Street at Kurraba Road will significantly impact on the traffic flow in the surrounding streets especially for Aubin Street.</p>
